INVENTORY of SITES & ITEMS

CARDIFF SOUTH

## HERITAGE STUDY

NAME/IDENTITY **Fmr COLLIERY TRAMWAY, MACQUARIE Rd, CARDIFF SOUTH** ITEM No. **CS - 01**

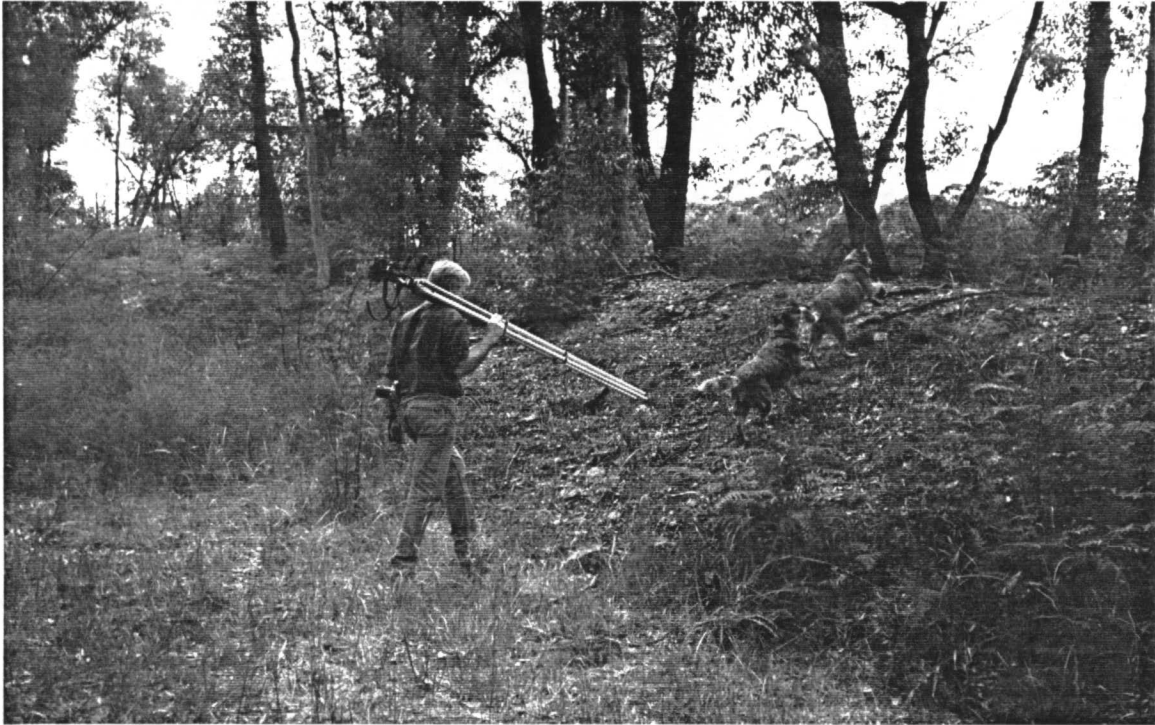
NAME/IDENTITY: Fmr COLLIERY TRAMWAY, MACQUARIE Rd, CARDIFF SOUTH		ITEM No. CS - 01
PREVIOUS/OTHER NAMES OR USES:		
ADDRESS: Macquarie Road Cardiff South 2285		S.H.I.P. REF. No.
PARISH: KAHIBAH COUNTY: Northumberland		DATE INSPECTED: November 1992
PRESENT OWNER(S) (Name & Address):		BY: Doring
		REAL PROPERTY DESCRIPTION:
		SITE AREA: CURRENT ZONING:
CATEGORY: Archeological/Historic Site	MAP 1:25000 No. 9232-3-S	
SUBCATEGORY: Other Mining	NAME: Wallsend GRID: 742 521	
HISTORICAL THEMES: S.H.I.P.:  LOCAL:	Ref. Nos. for RELATED ITEMS	
HISTORICAL PERIOD - BUILT: 1851-1875 ?		USED: ?
BUILDER:		DATE BUILT: c1870s ?
ARCHITECT/DESIGNER:		
PHOTOGRAPH &/OR SKETCH PLAN (and caption): Tramway embankment on the west of Macquarie Rd. The tramway crosses a cutting in Macquarie Road, out of sight to the left. (Doring Neg.459.34)

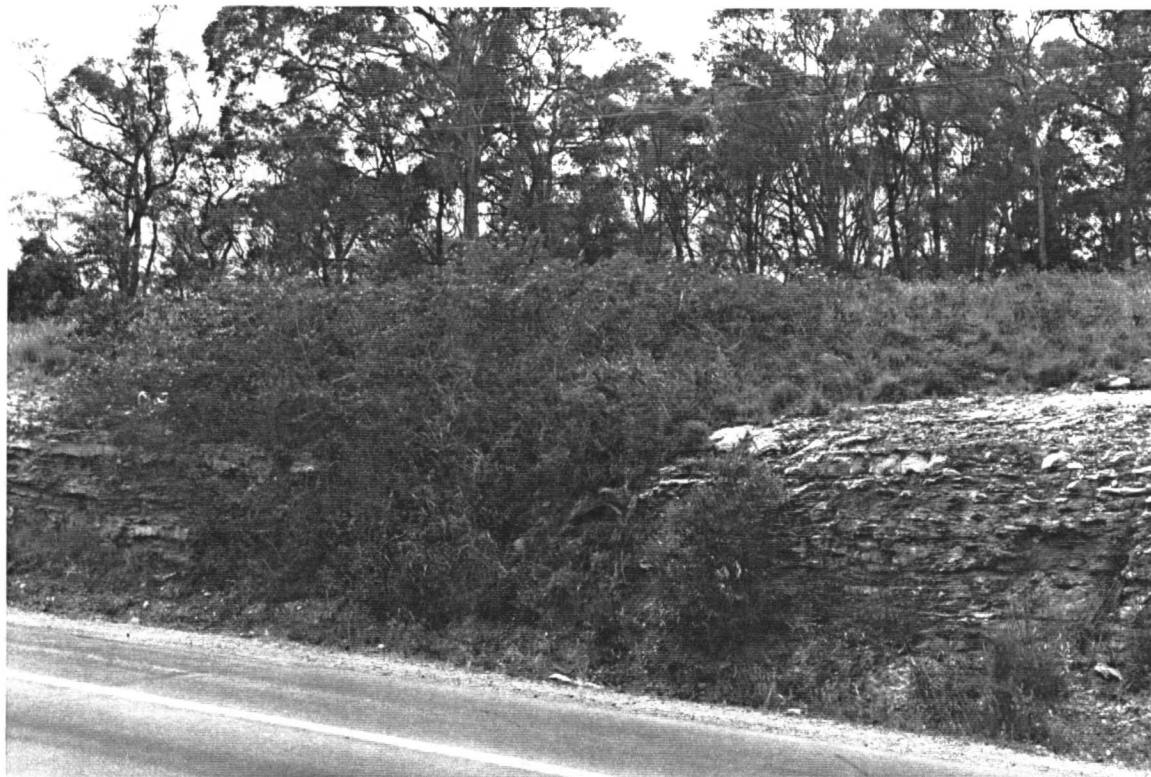
Clearly visible embankment west of Macquarie Rd. Tramway cutting and a section of rail exposed in the modern road cutting. The tramway is at about 30 to 40 degrees to roadway. Most of route not explored, but it is possibly parallel with Haddington Dr. There may be more rail in other sections. Traces of the drift entrance said to have been destroyed in a recent housing development. Fan House ruins said to still exist at the South Cardiff end. The rails are an early light weight type for industrial tramlines, probably wrought iron.

Top: Cutting in Macquarie Road South Cardiff, at the place where the road cutting passes through the colliery tramway cutting. Viewed from the south-south-west, looking along the tramway. The former tramway cutting is partly filled (note break in exposed rock strata) and a twisted piece of tramline projects from the soil (left of the small bush) in the cutting. (Doring Neg.445.25)

None. It is recommended that at least a short section of the tramway, on both sides of Macquarie Rd, should be exposed, recorded, stabilised, conserved and interpreted.

RECOMMENDATIONS: Provide immediate protection for the tramway relics as they are under threat from housing developments, and possible road works. Layout of new house sites could be arranged to avoid the tramway. Also implement the conservation action recommendations outlined above.

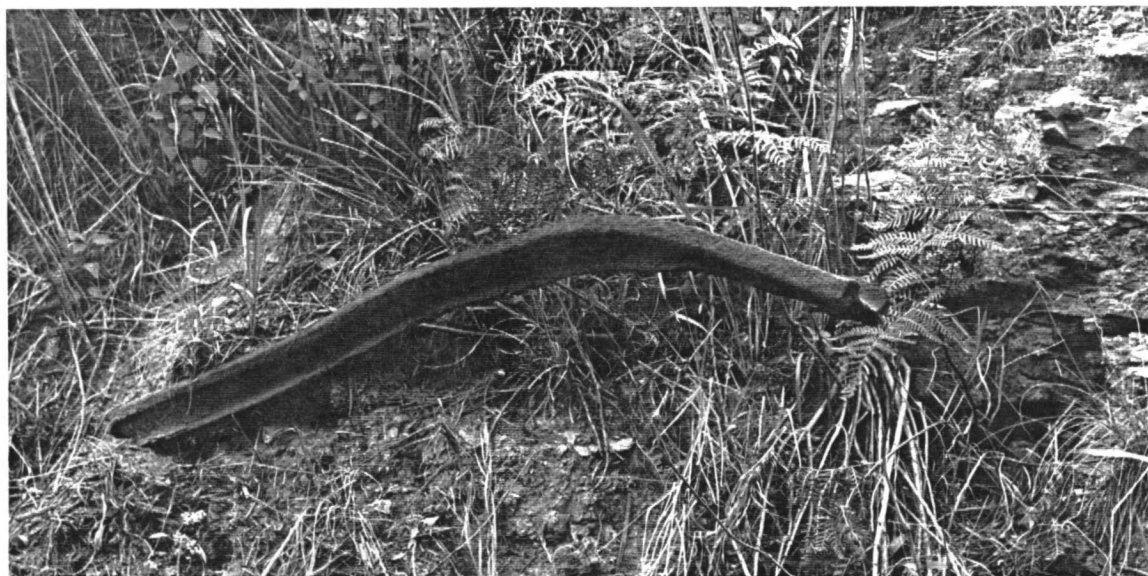
Bottom: Detail showing the section of twisted tramway rail visible in the cutting in Macquarie Road (east side). (Doring Neg.445.13)
