## **‘GOLDEN MILE’ PAVERS RECORDING**

Withers Street, West Wallsend

**'GOLDEN MILE' PAVERS  
RECORDING – WITHERS STREET,  
WEST WALLSEND**

Project Director: **Tim Adams**  
Project Manager: **Amanda Reynolds**  
Report No. **3221/R03/FINAL**  
Date: **May 2014**

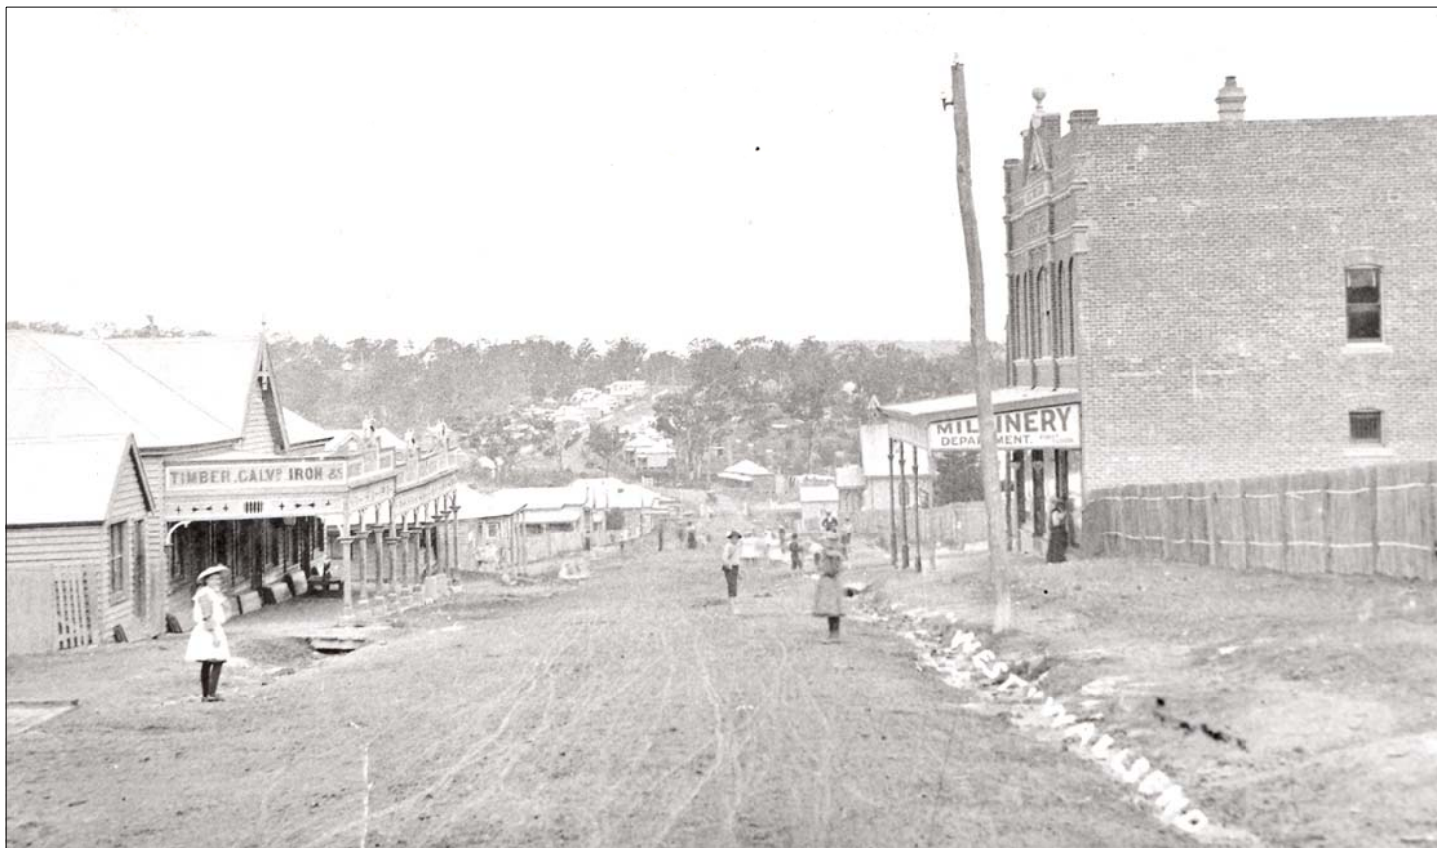
FIGURE 2.1

Early 1900s Photograph Looking South Down Withers Street Showing 1906  
Constructed Brick Co-op Building on Corner of Withers and Brown Streets

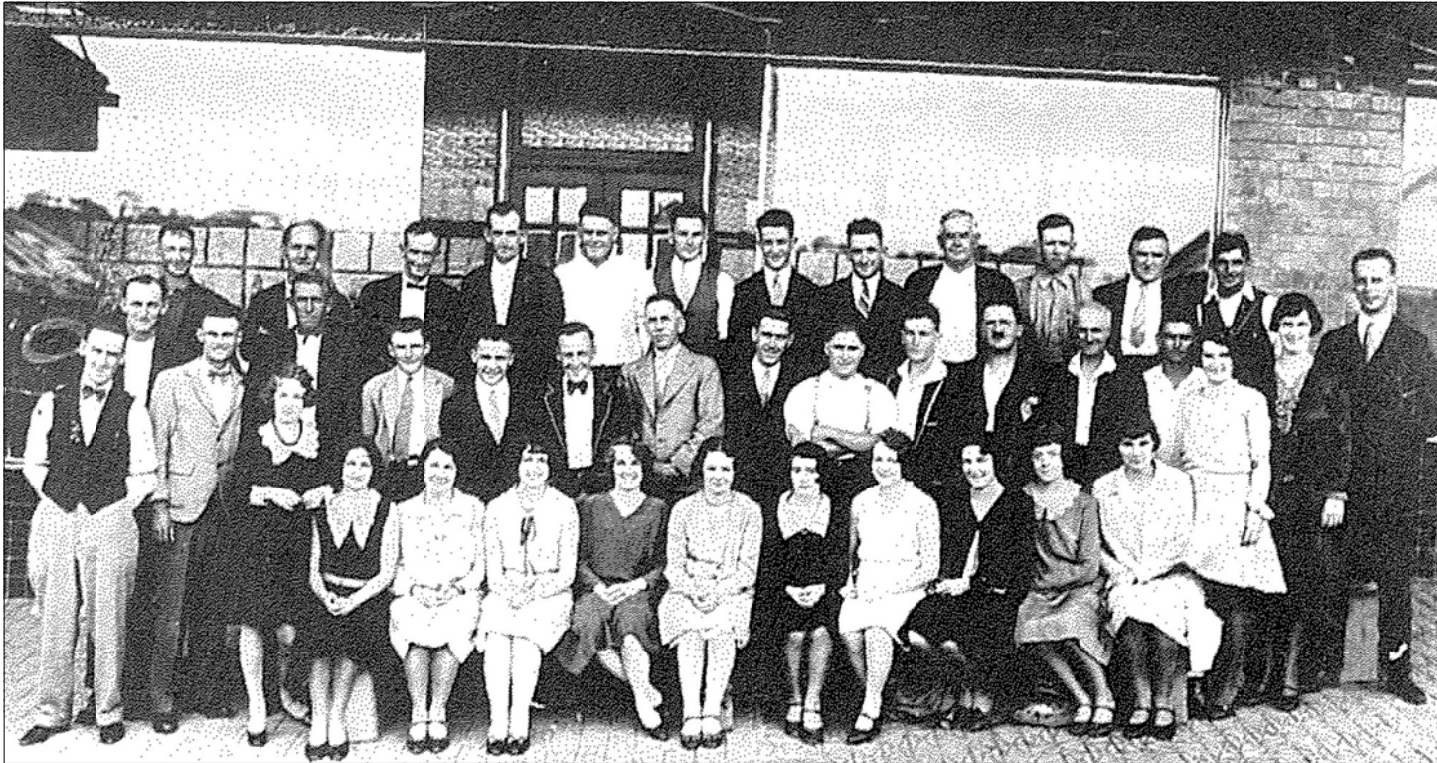
FIGURE 2.2

1930s Photograph Showing Co-operative Store Staff on Footpath in Front of Store. Note 'Golden Mile' Brick Pavers

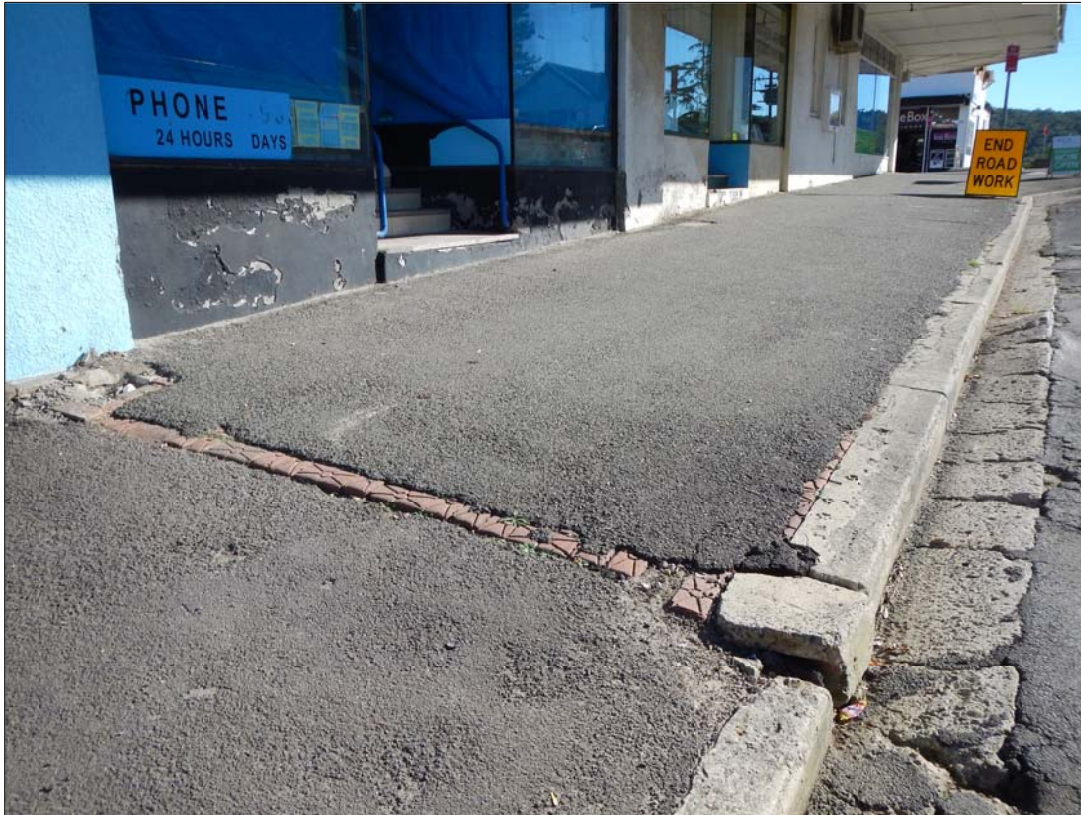
PLATE 3.1  
View to north along west side of Withers Street to Carrington Street  
Corner showing 1930s pavers beneath asphalt footpath surface

Prior to the street upgrade works commencing, remnant 1930s constructed pavers were evident beneath the then existing asphalt footpath surface on the west side of Withers Street. These pavers appear to have formed the footpath surface outside the Co-op Store buildings on the west side of Withers Street and outside the Withers Street/Carrington Street corner building (refer to **Plate 3.1**).

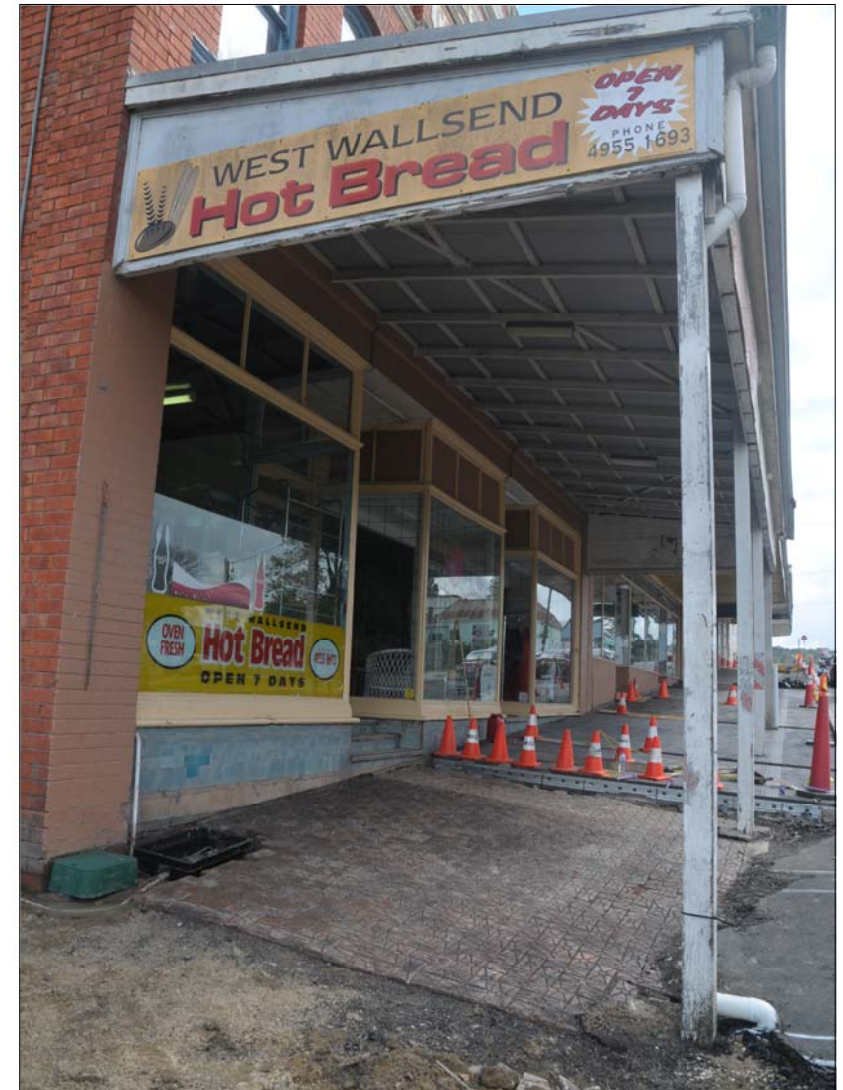
PLATE 3.2  
View to northwest showing southern limit of brick pavers at Withers  
and Brown Street Corner

The pavers commenced at the corner of Brown and Withers Street in line with the edge of the 1906 constructed corner Co-op building (the current West Wallsend Hot Bread shop) (refer to **Plate 3.2**) and continued up Withers Street towards Carrington Street (refer to **Plate 3.3**). The pavers stopped at the edge of the northern most 1927 constructed Co-op parapeted building (the current IGA supermarket) at the edge of the gap in the Co-op store buildings. No pavers were exposed in the gap in the Co-op buildings, however the pavers continued on the other side of the gap alongside the Withers and Carrington Street Co-op corner building (refer to **Plate 3.4**). It is likely this area of footpath, in the gap between the Co-op buildings, was never paved (refer to **Plate 3.5**). From the north side of the gap the pavers continued round the Withers and Carrington Street corner to the edge of the Co-op buildings on Carrington Street (refer to **Plate 3.6**).

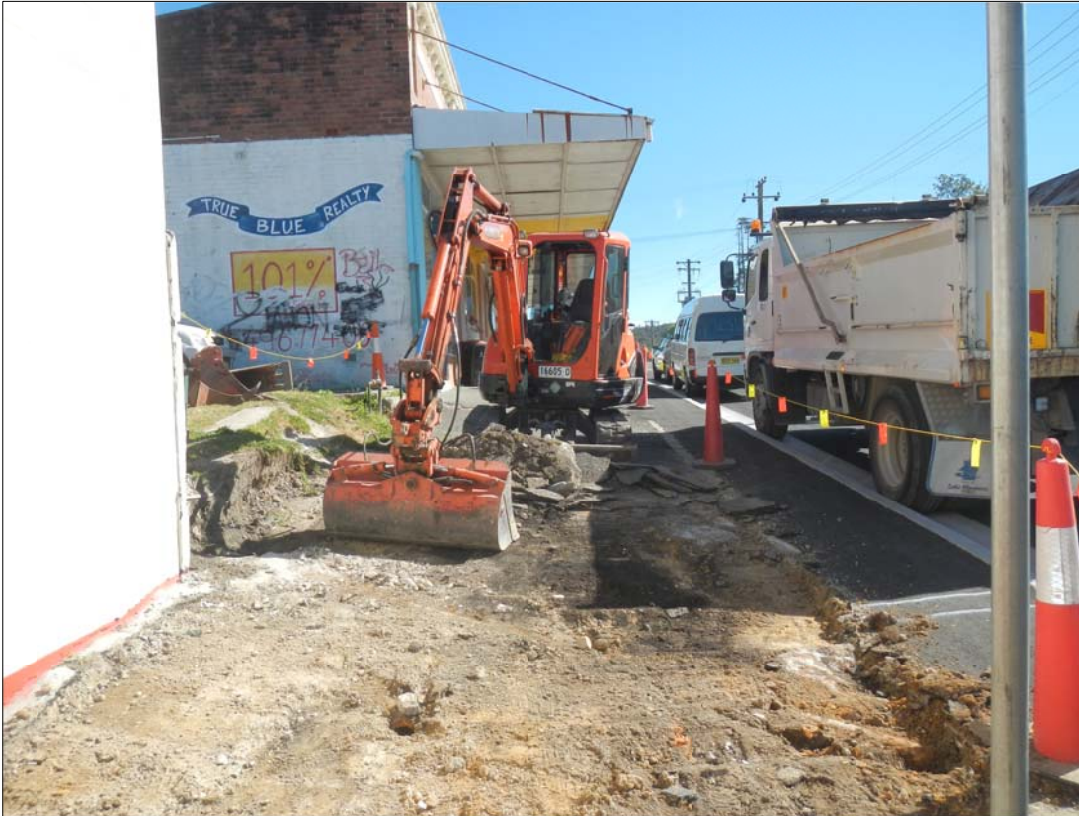
PLATE 3.5

View to north during removal of asphalt footpath surface in gap between the Co-op buildings - note no pavers present

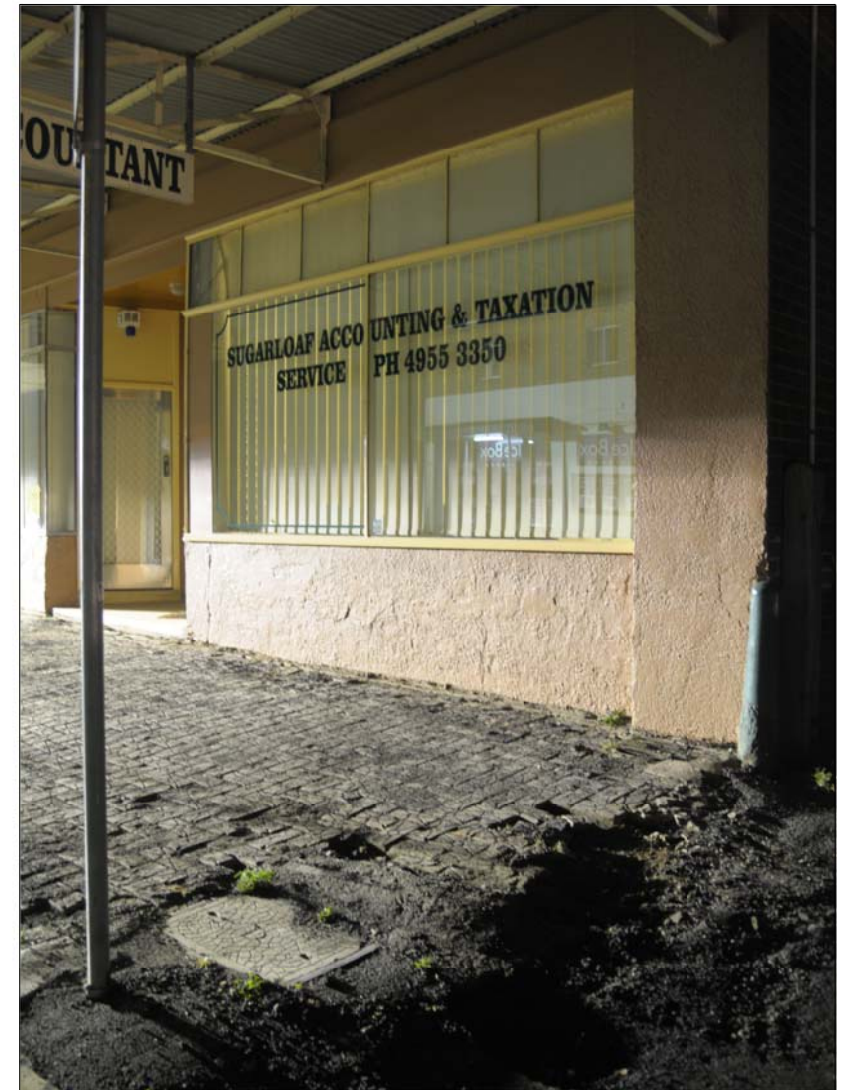
PLATE 3.6

View to southeast showing limit of brick pavers in front of 1910-1915 Co-Operative Society Building on Carrington Street

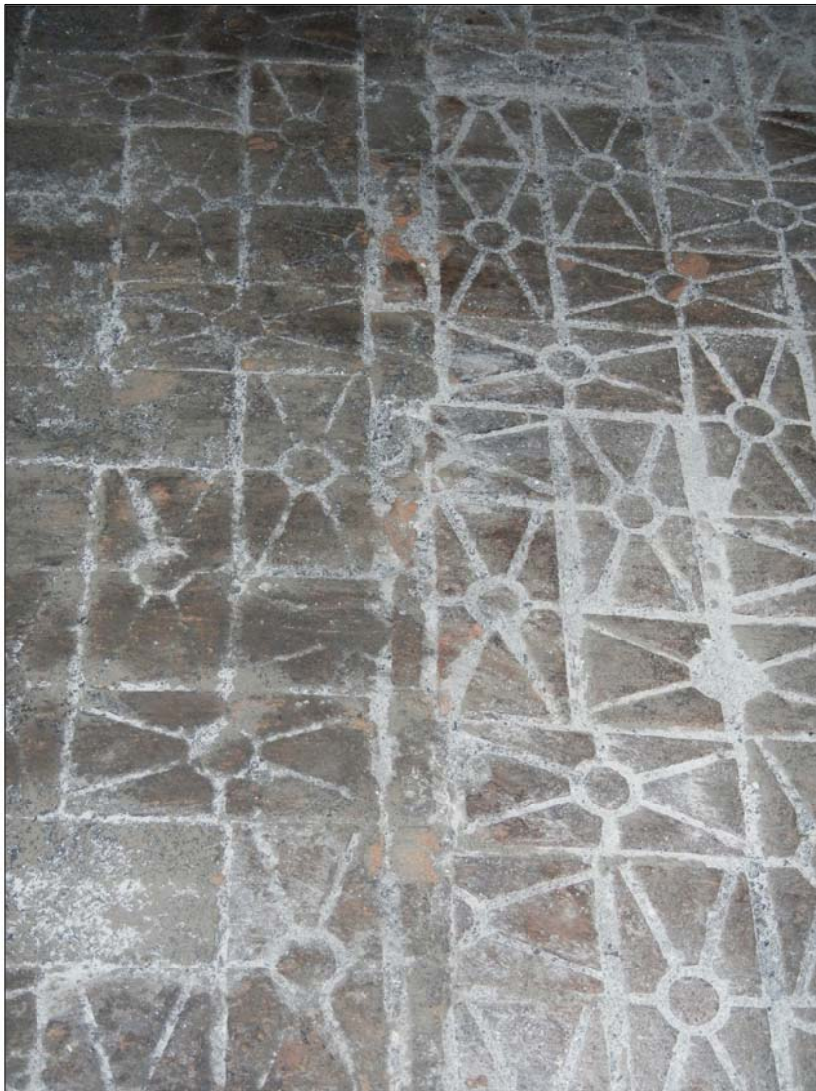
PLATE 3.7

The pavers were laid in a herringbone pattern and may have been laid by different work groups working from different directions. The location where the different sections meet is evident with partial pavers being used at the join of the different sections. These joins are evident close to the Withers and Carrington Street corner (where the current Pharmacy building commences) and alongside the entrance to the current Newsagents building (refer to **Plate 3.7**).

Detail of joint line of pavers in front of 1927 Parapet Building on Withers Street

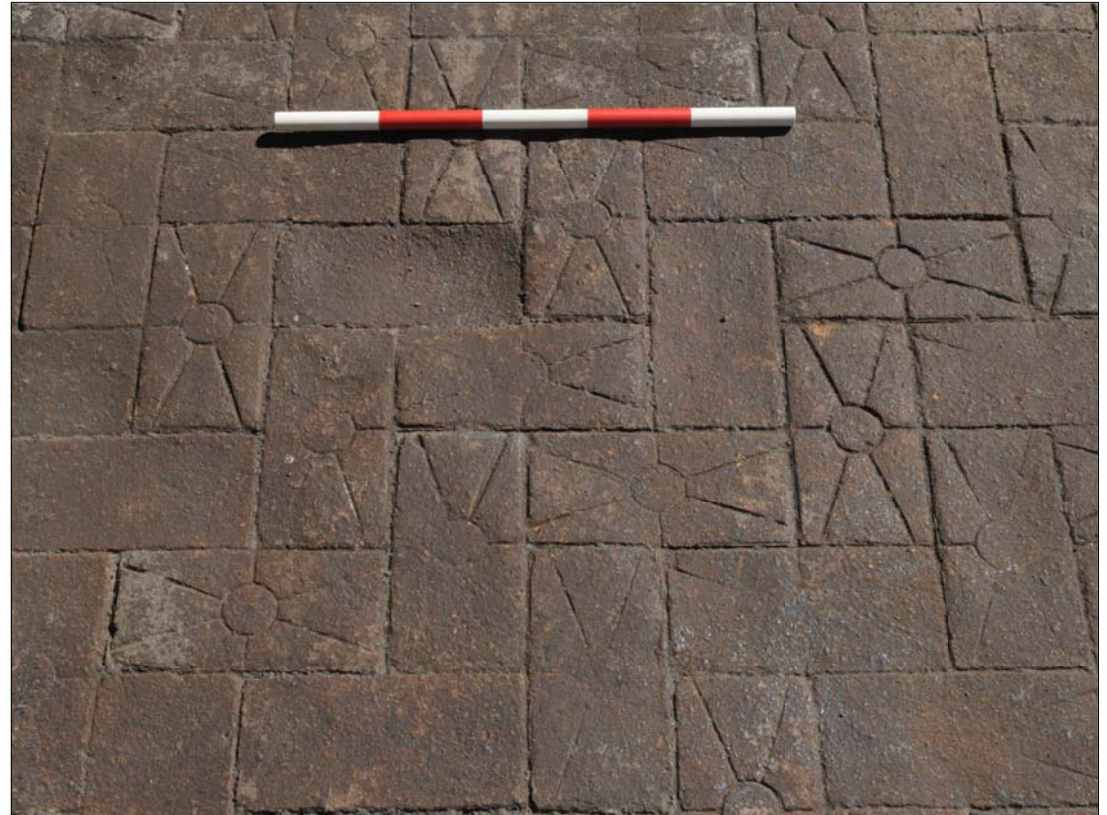
PLATE 3.8

In places the pavers have worn to the extent that their pattern is no longer distinguishable. This is especially evident outside the 1927 constructed Co-op parapeted buildings towards the Brown Street corner (refer to **Plate 3.8**).

Detail of weathered pavers in front of 1927 Parapet Building on Withers Street (Scale = 500 millimetres)

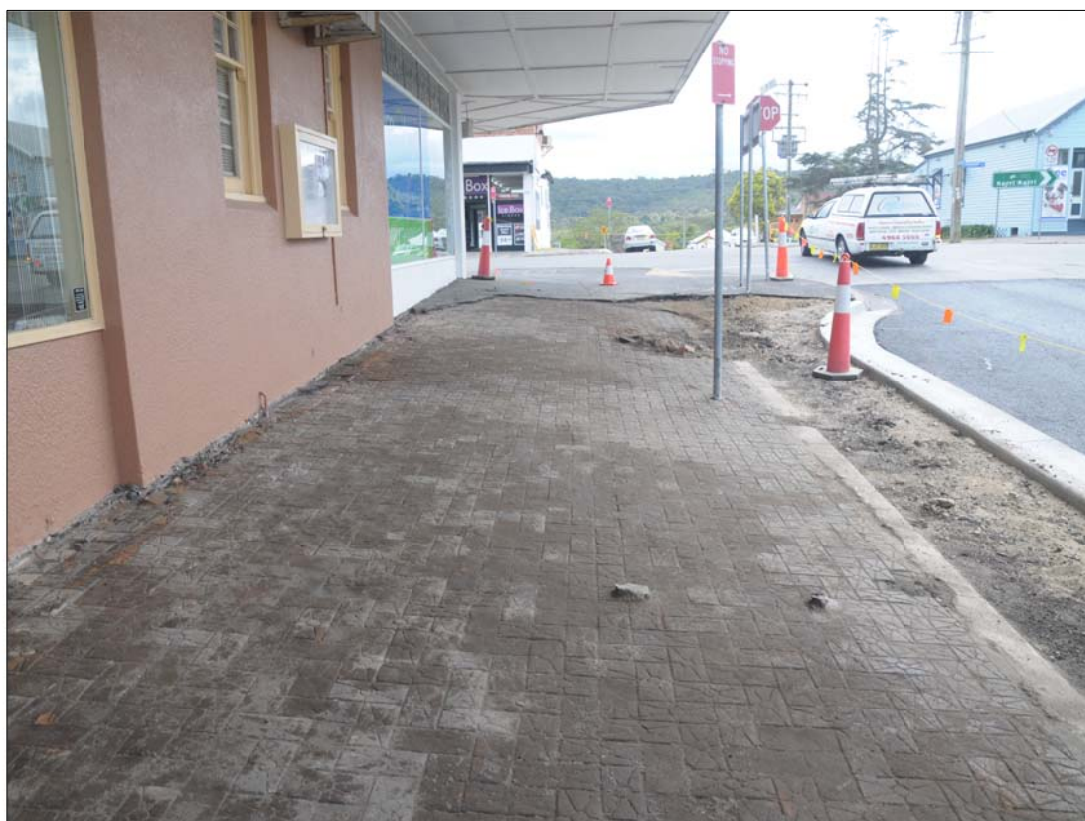
PLATE 3.9

The base of metal posts of a former sign post are evident, cutting the brick pavers close to the Withers and Carrington Street corner (refer to **Plate 3.9**). The sign post is unlikely to have been related to the date or use of the brick paved footpath as the posts also cut through the asphalt surface above the pavers.

View to north showing brick pavers in front of 1927 Co-Operative Society Withers and Carrington Street Corner Building. Note base of metal posts

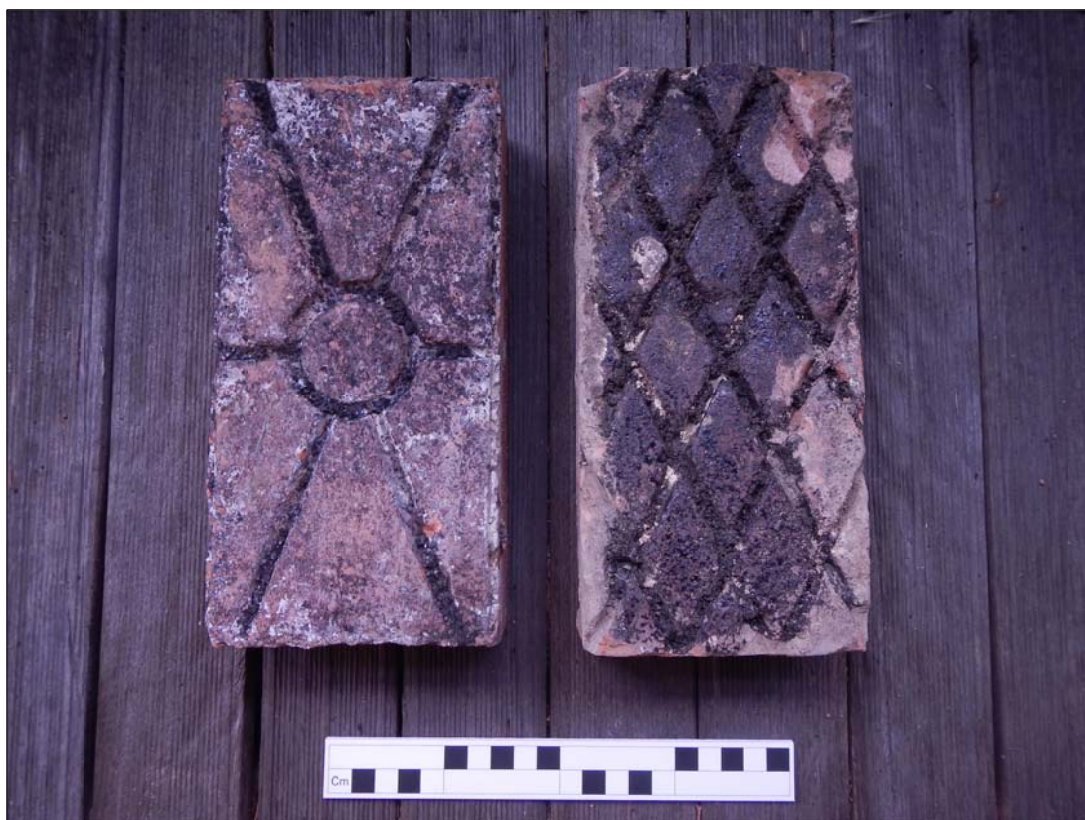
PLATE 3.10

Two different types of brick pavers from two different Brickworks were exposed during the removal of the asphalt footpath surface (refer to **Plate 3.10**). The brickworks comprised:

- Lincoln Brickworks in Wingham near Taree; and
- Frith’s Brickyard in Holmsville.

Lincoln Brickworks (on left) and Frith's Brickworks (on right) brick paver (scale = 200 millimetres)

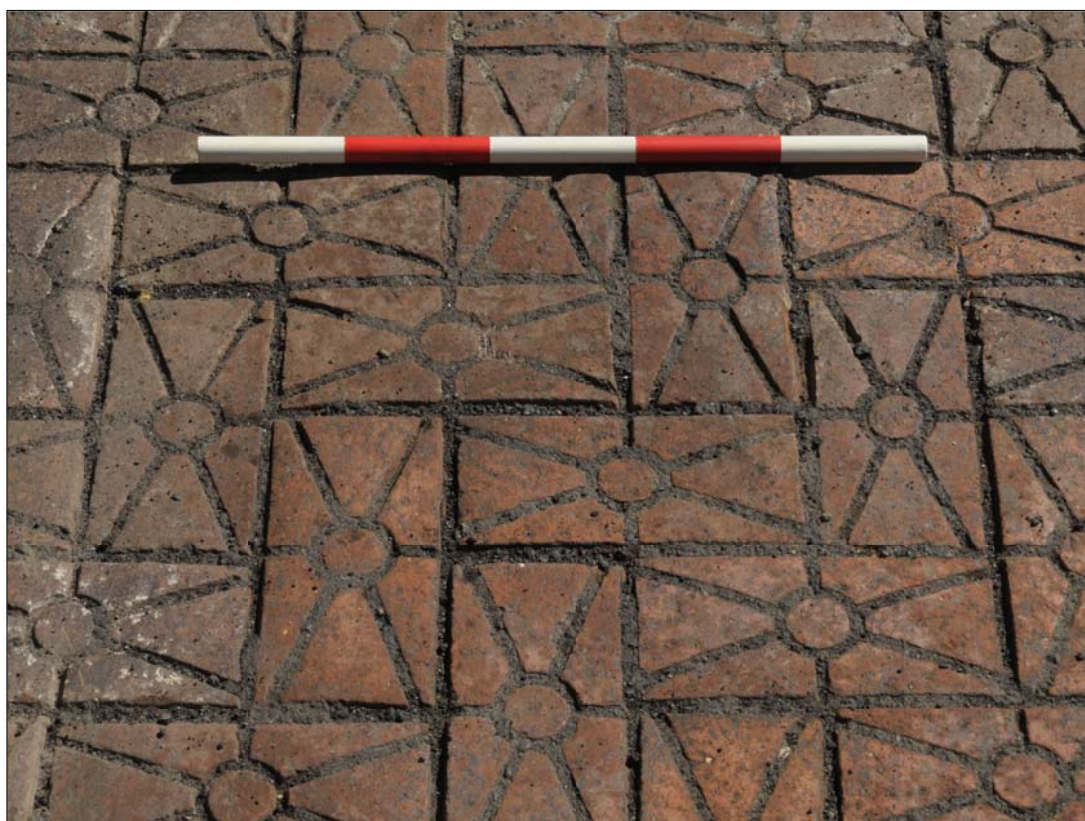
The Lincoln Brick Wentworth type of paver exposed during LMCC works was an orangey red coloured paver with a distinctive surface pattern measuring on average 225 by 113 by 55 millimetres (refer to **Plate 3.11**).

PLATE 3.11  
Detail of pavers in front of 1927 Parapet Building on Withers Street (Scale = 500 millimetres)

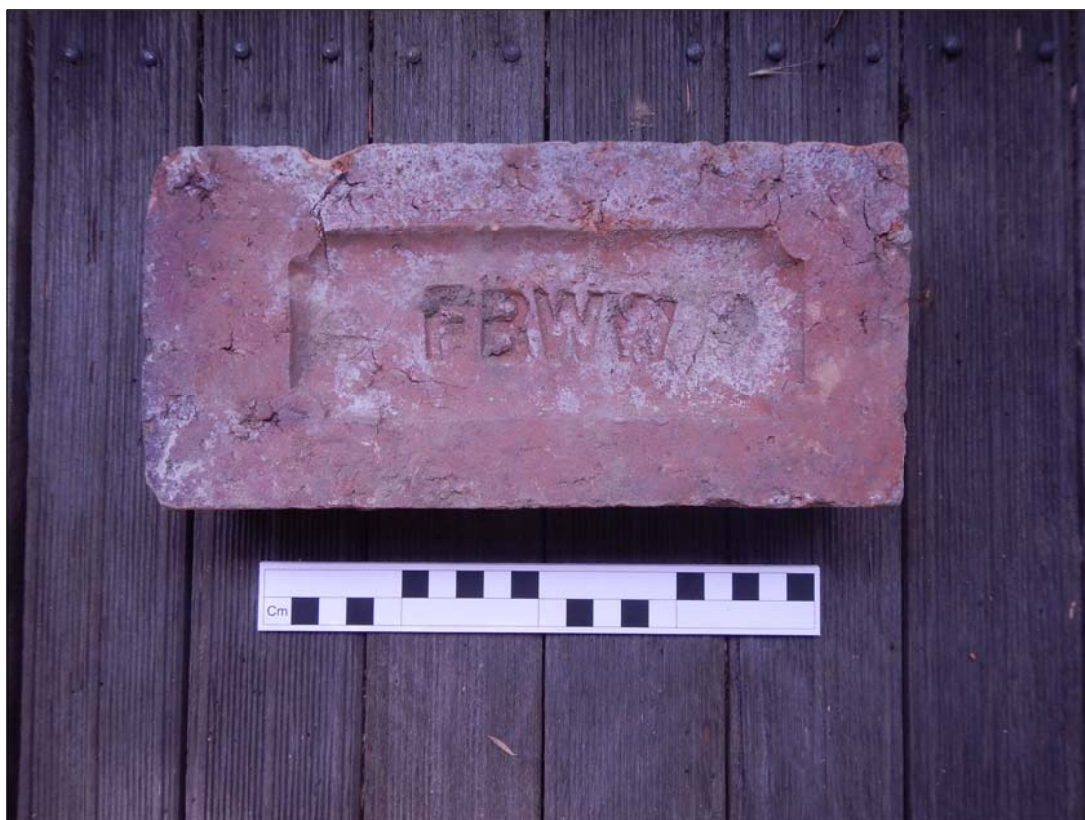
The Friths Brickyard pavers exposed during LMCC works were a similar orangey red coloured brick paver with a diamond surface pattern measuring on average 230 by 111 by 65 millimetres (refer to **Plate 3.10**). The underside of the brick paver is stamped with the letters ‘FBWW’ (Frith’s Brickyard West Wallsend) (refer to **Plate 3.12**).

PLATE 3.12  
Detail of Frith's Brickworks brick paver stamp (scale = 200 millimetres)

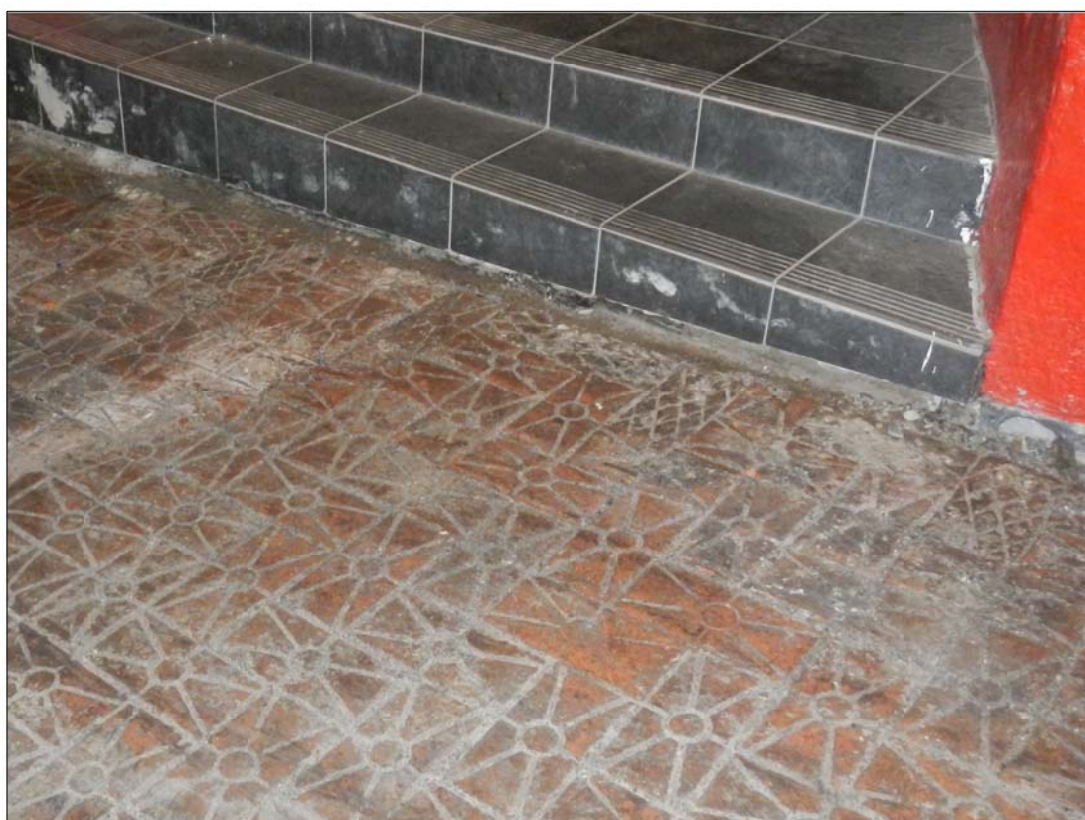
PLATE 3.13

As discussed, the majority of the pavers were sourced from Lincoln Brickworks, however a small number were sourced from Frith's Brickyard. The Frith's Brickyard pavers may have been used to replace worn or damaged Lincoln Brickwork's pavers; being a local company they would have been easier to source than ordering from the Lincoln Brickworks. The Frith's Brickyard pavers were identified in isolated areas adjacent to the entrances to a number of the store buildings (including the current Newsagents and IGA supermarket within the 1927 constructed Co-op parapeted buildings) that may have been high trafficable areas or damaged during upkeep works to the Co-op building entrances/steps.

**Plate 3.13** shows the Frith's Brickyard pavers alongside the entrance to the current IGA supermarket – the northernmost shop in the 1927 constructed parapeted buildings.

Detail showing Frith's Brickyard pavers alongside the entrance to the current IGA supermarket

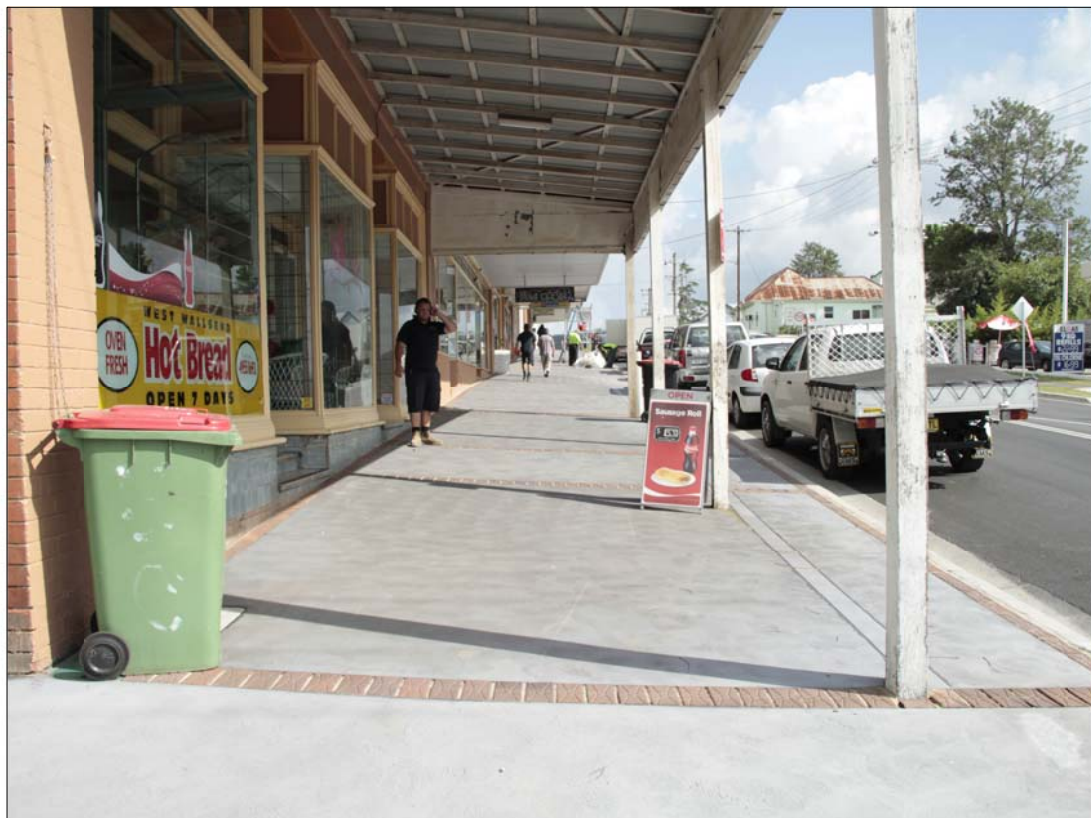
PLATE 4.1

View to northwest showing 1906 Co-op building on corner of Withers and Brown Streets at end of works. The former locations of the 1930s pavers are shown in the footpath as bands of replacement pavers

As part of the 2013 LMCC streetscape works, replacement pavers were sourced from Lincoln Brickworks and used, in the form of banding, to indicate the extent and locations of the original pavers. In addition, lines were etched along the inside edge of the new kerb to show the original width of the Golden Mile footpath and the likely location of the original kerbing (refer to **Plate 4.1**). Examples of the original brick pavers have been used in the brick banding between the newsagents and the IGA supermarket. Original brick pavers have also been installed on the eastern corner of Withers and Brown Streets.

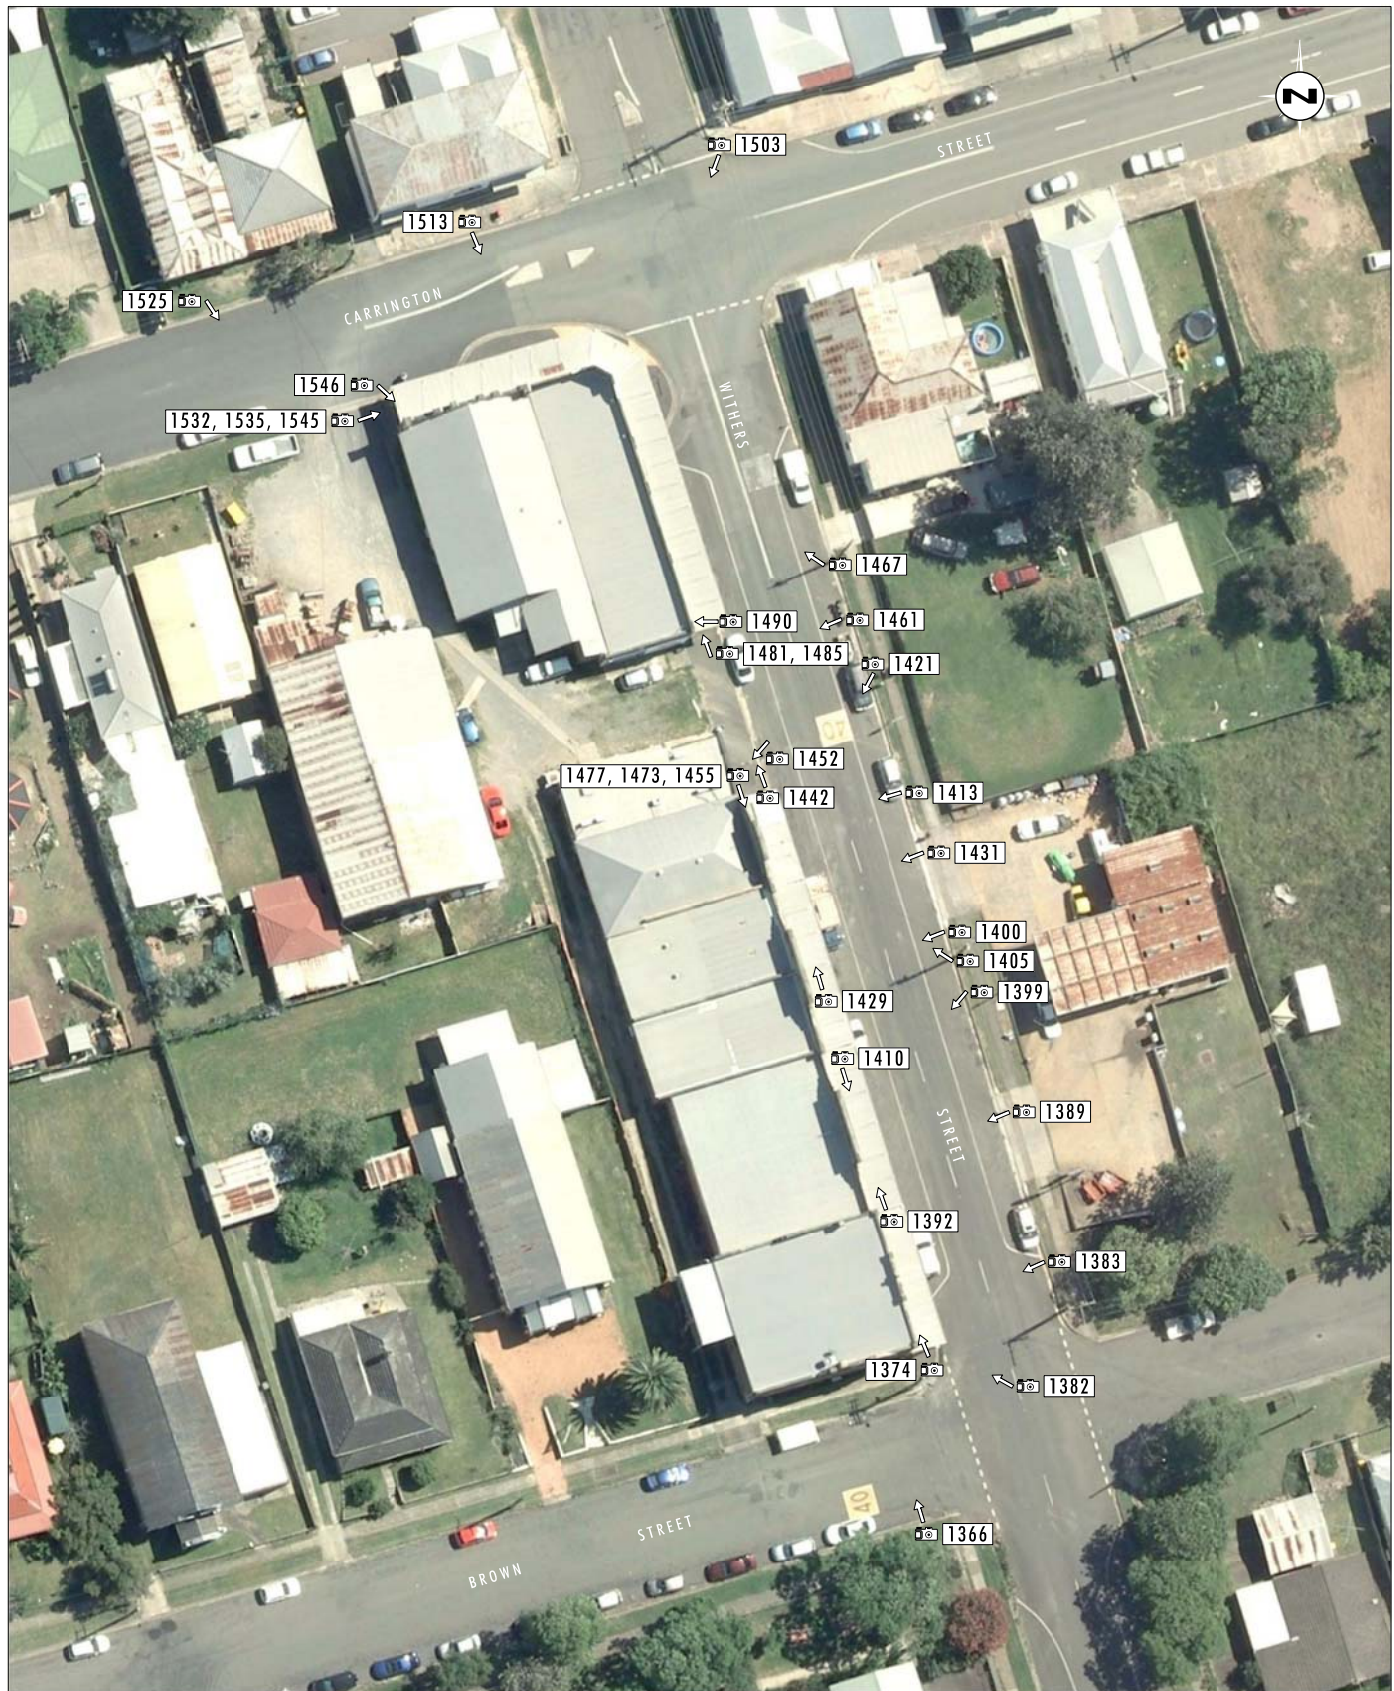
FIGURE A2

Photographic Plan A2

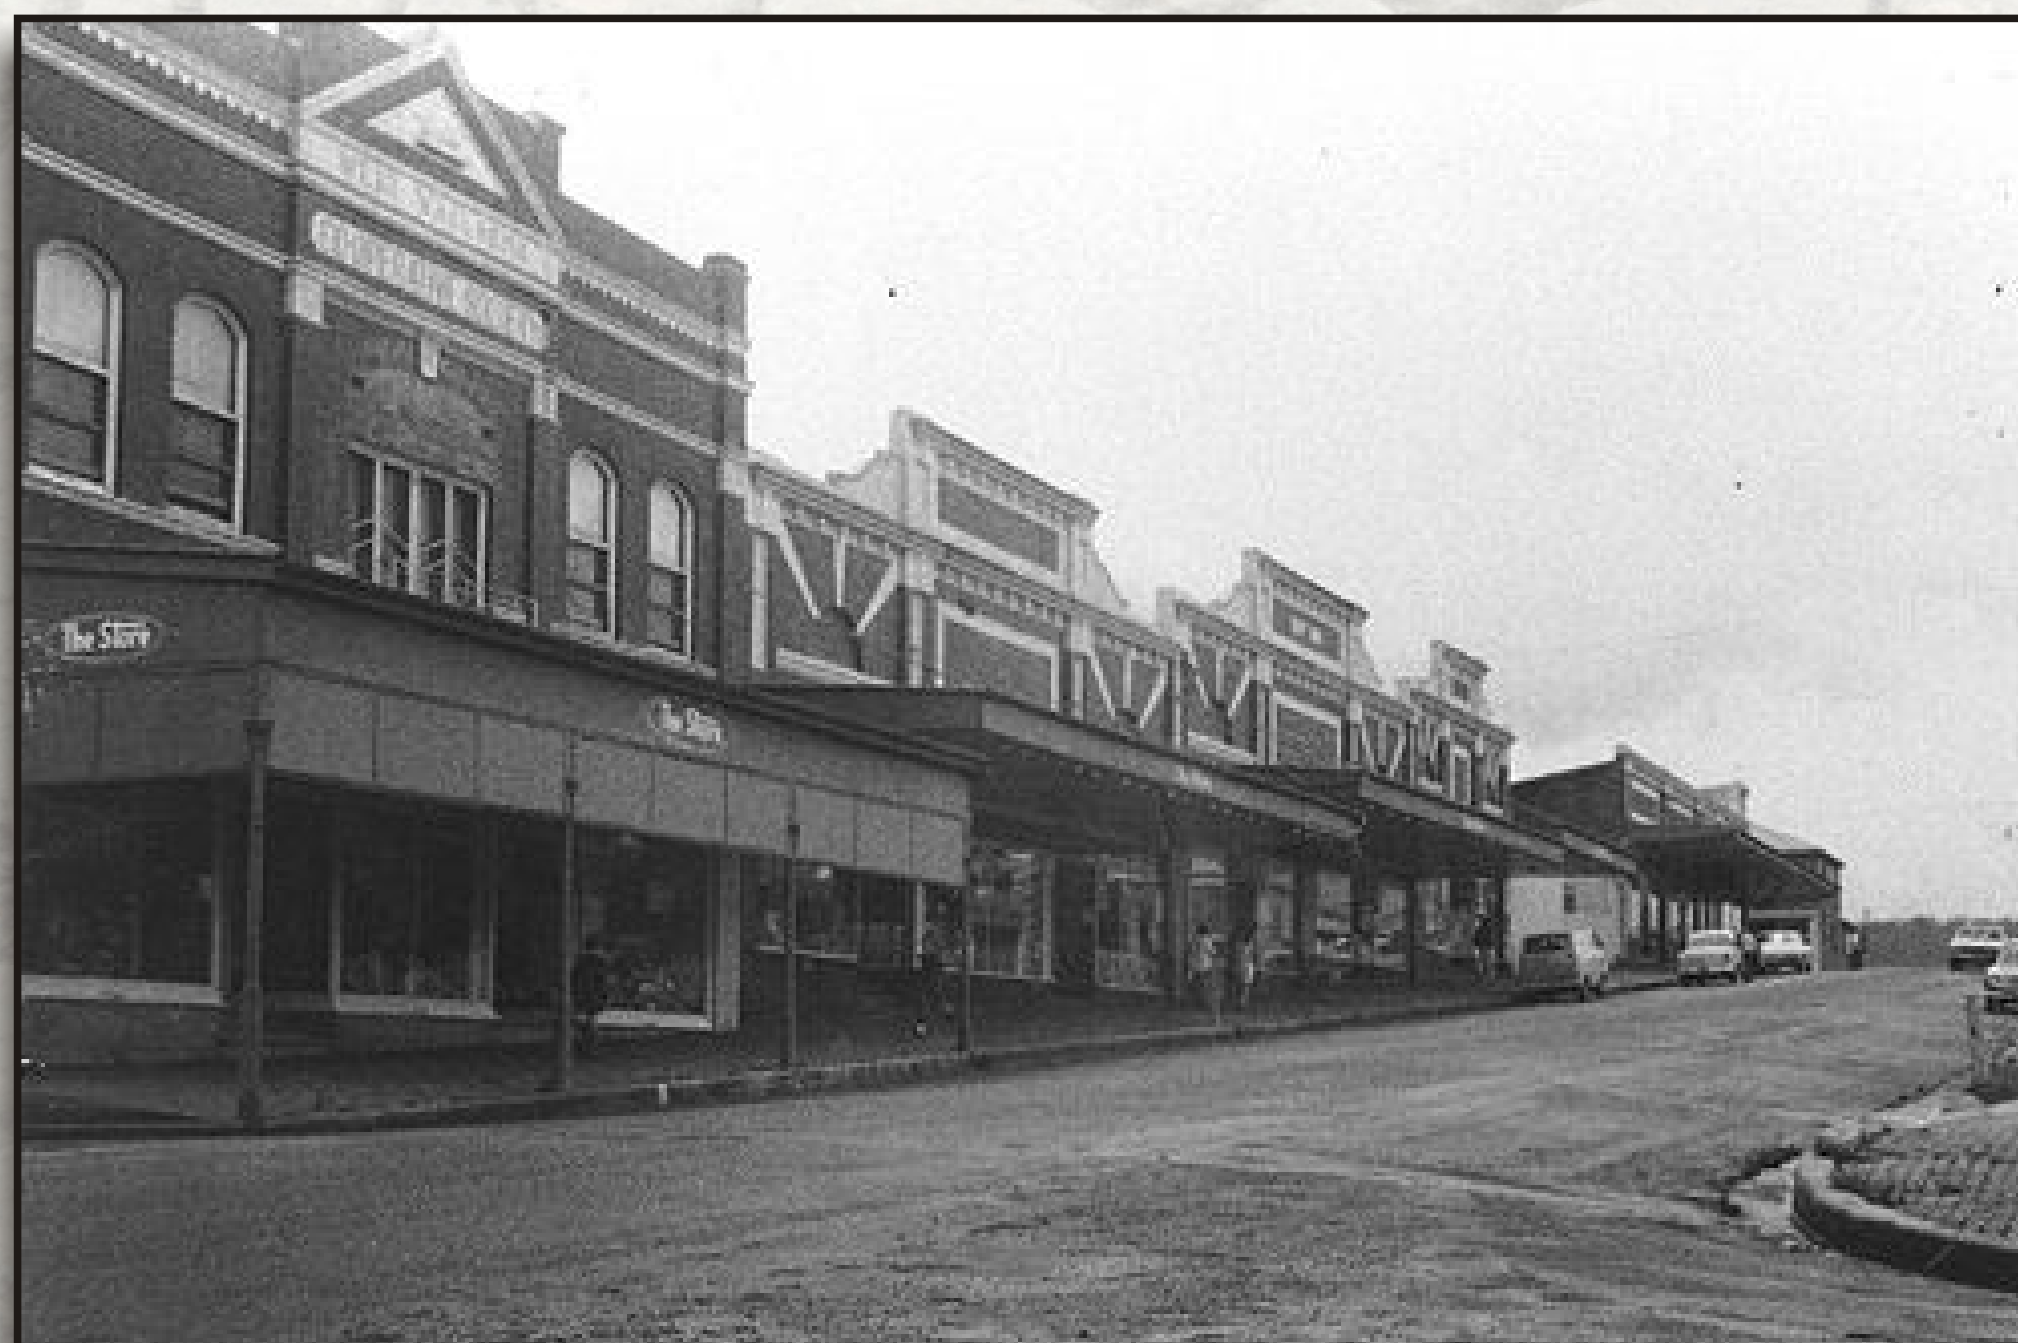
View up Withers Street from Brown Street. 'Golden Mile' pavers can be seen on both sides of the street.  
Image source: Lake Macquarie City Council

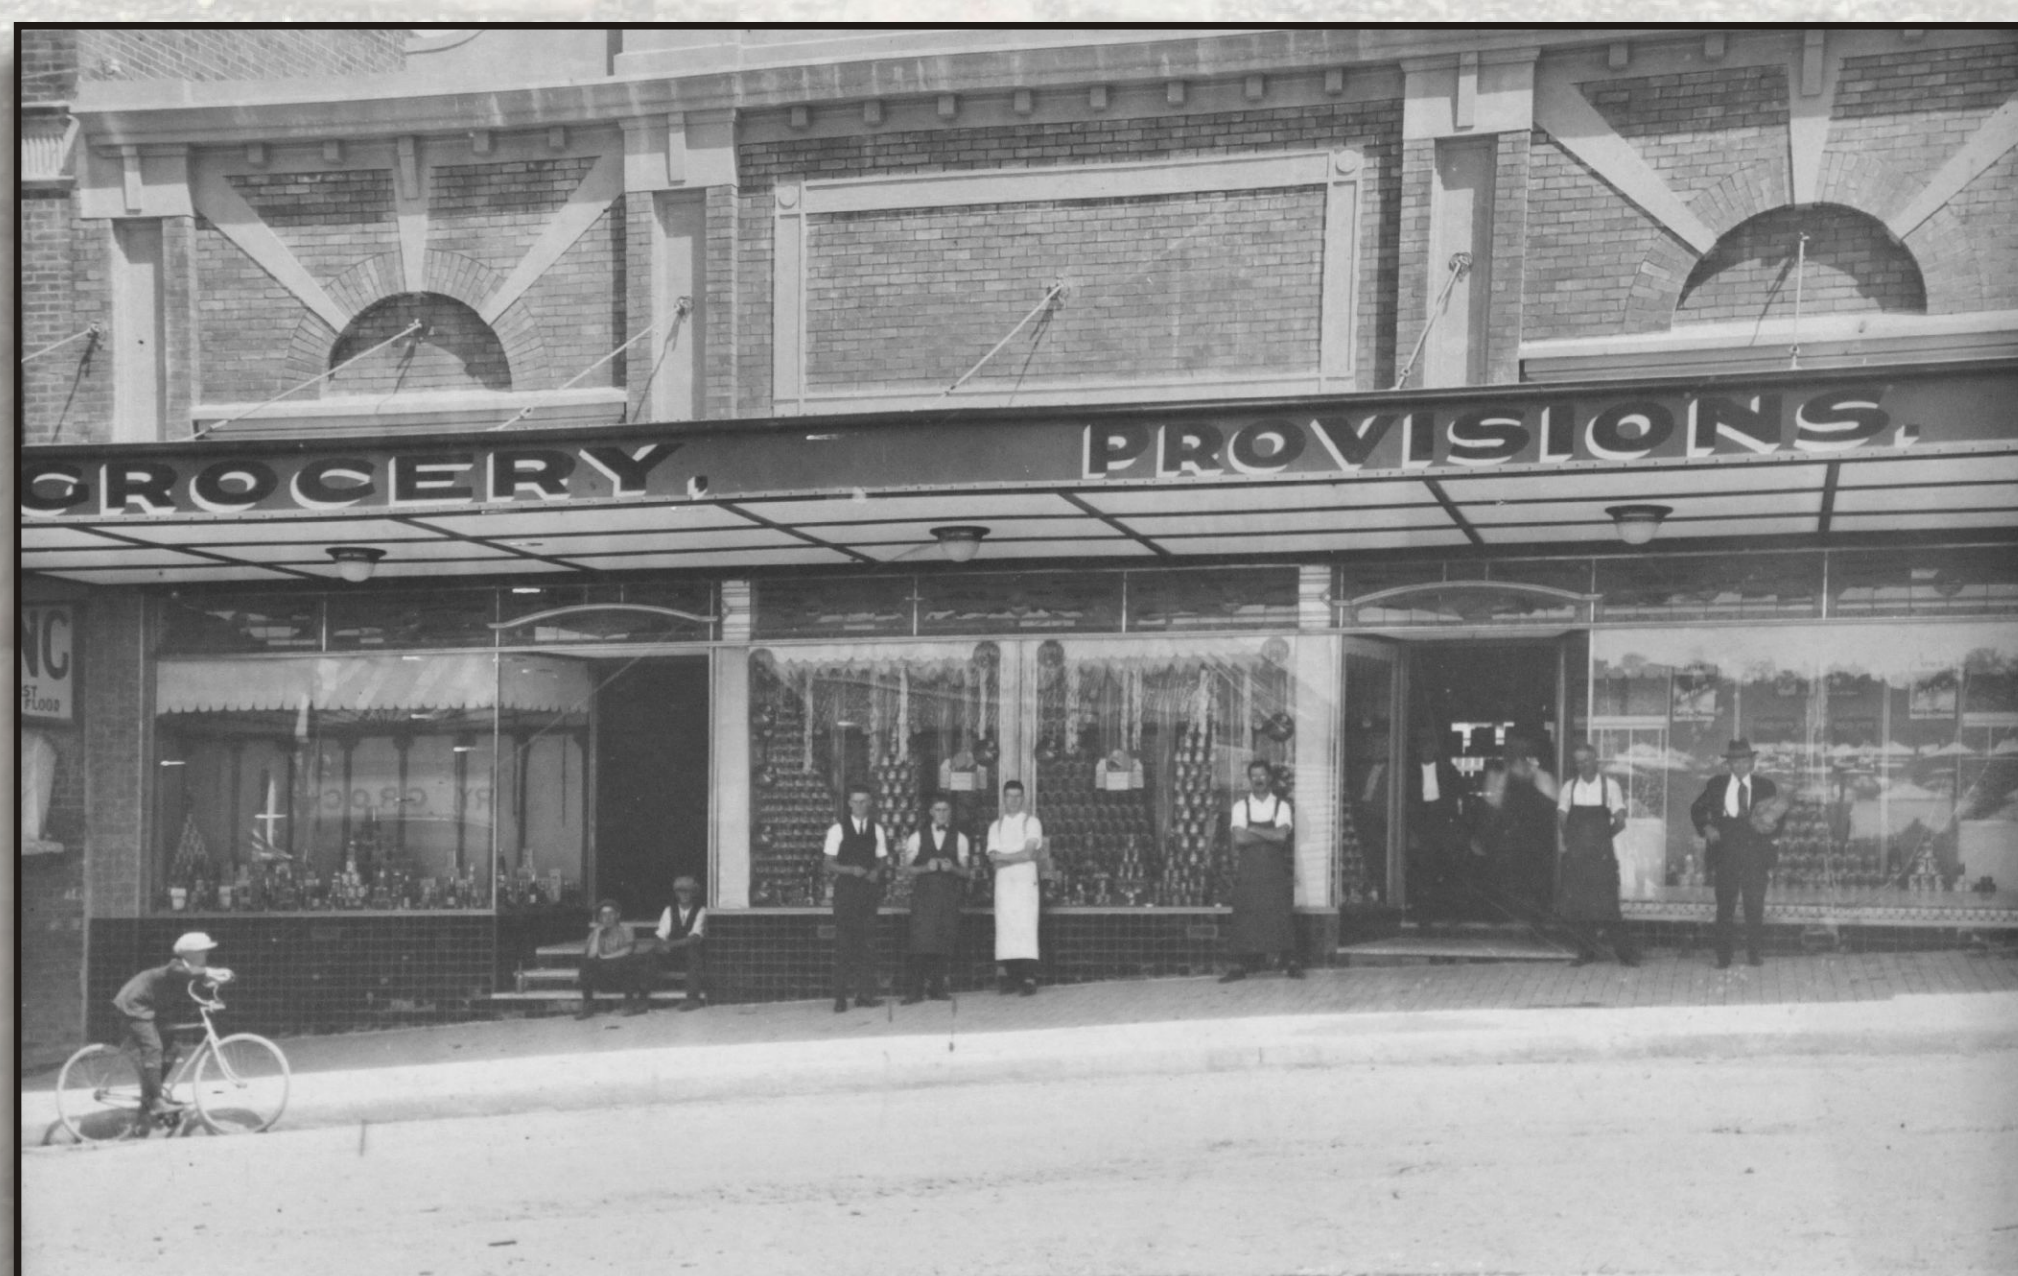
1927 Co-op Store buildings and the 'Golden Mile' pavers.  
Image source: West Wallsend District Heritage Group Inc.
