## **‘GOLDEN MILE’ PAVERS RECORDING**

Withers Street, West Wallsend

**'GOLDEN MILE' PAVERS  
RECORDING – WITHERS STREET,  
WEST WALLSEND**

Project Director: **Tim Adams**  
Project Manager: **Amanda Reynolds**  
Report No. **3221/R03/FINAL**  
Date: **May 2014**

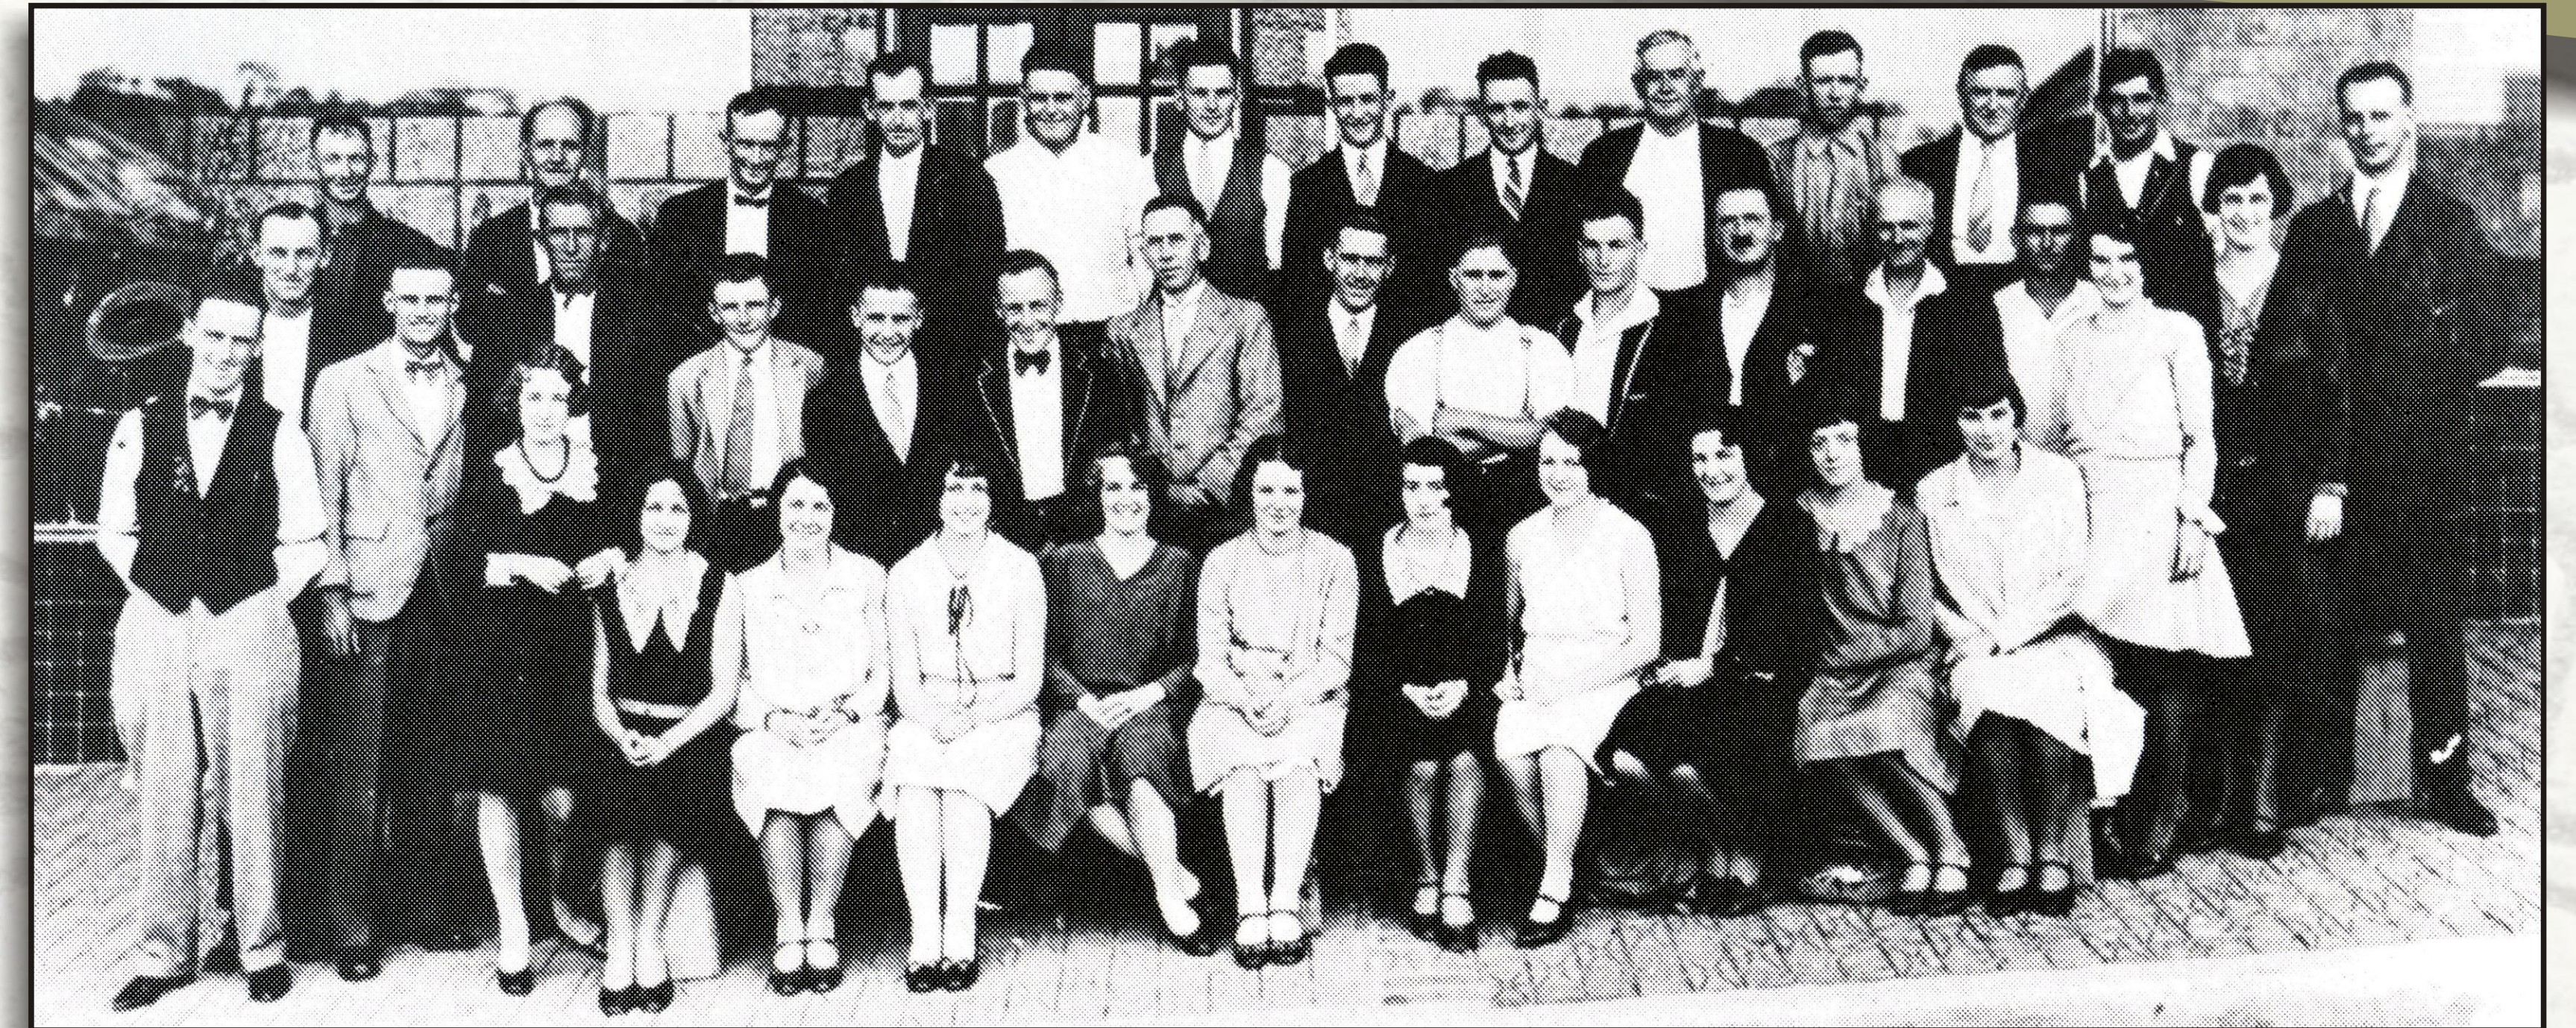
1930s photograph of the Co-op Store staff on the 'Golden Mile' paved footpath.

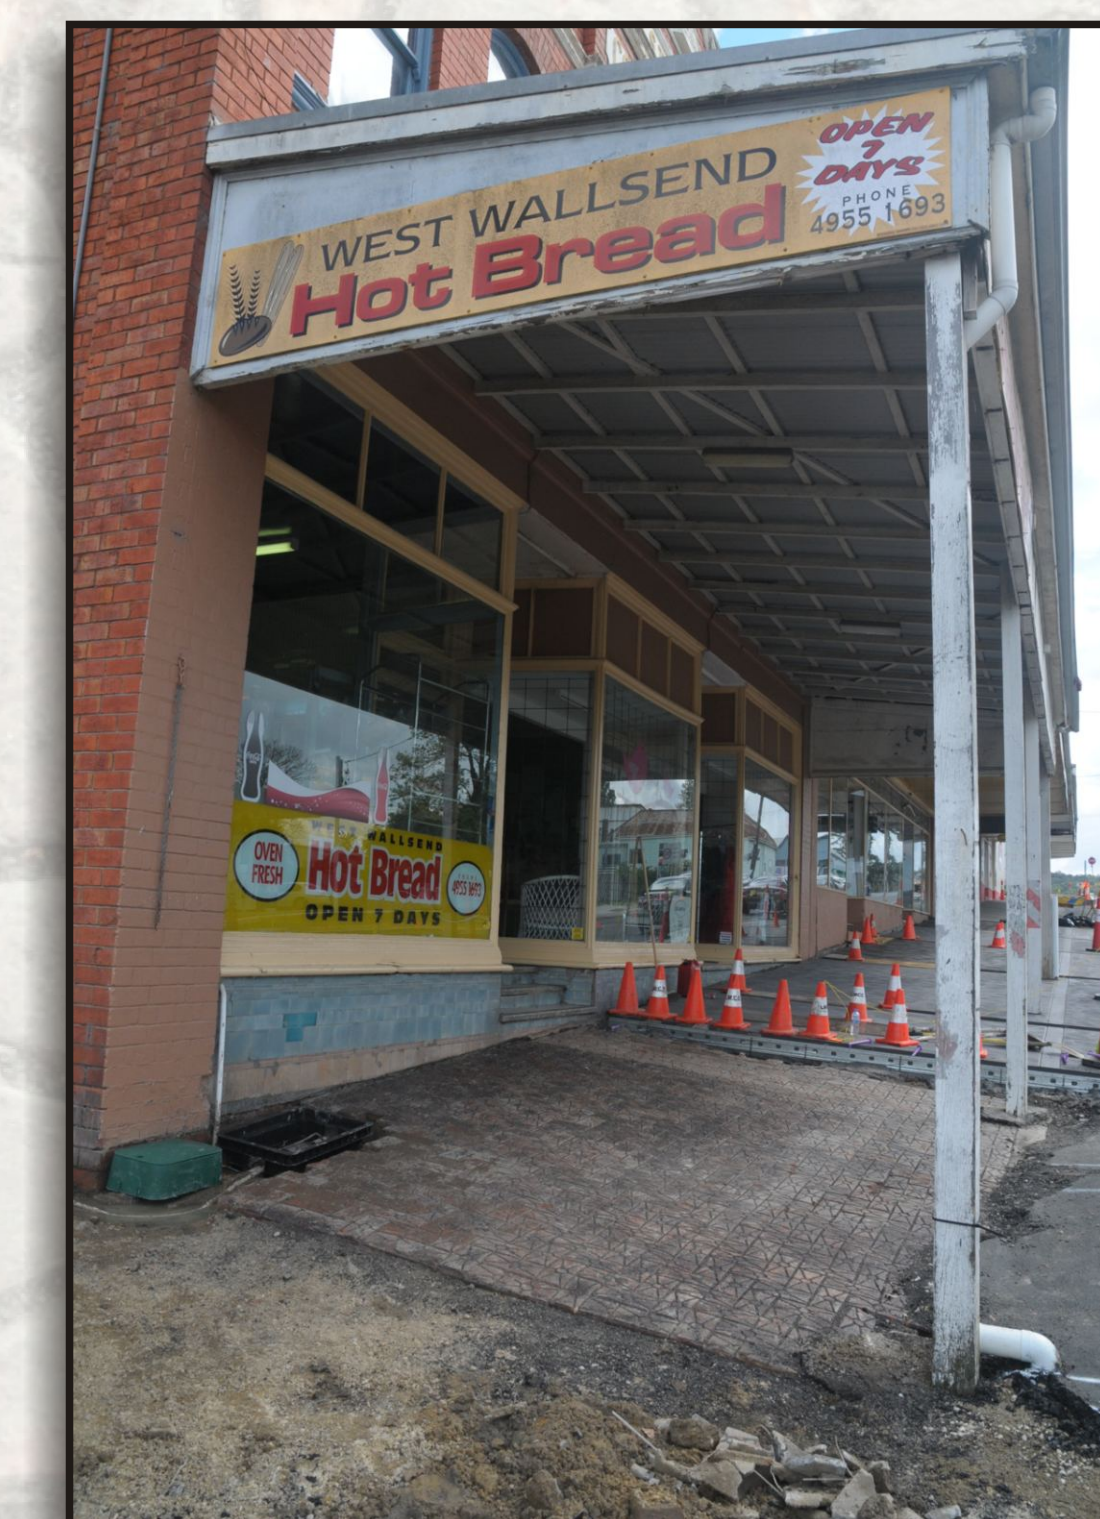
1906 built Co-op building on corner of Withers and Brown Street. The 1930s pavers were exposed during street upgrade works.  
Image source: Umwelt (2013)

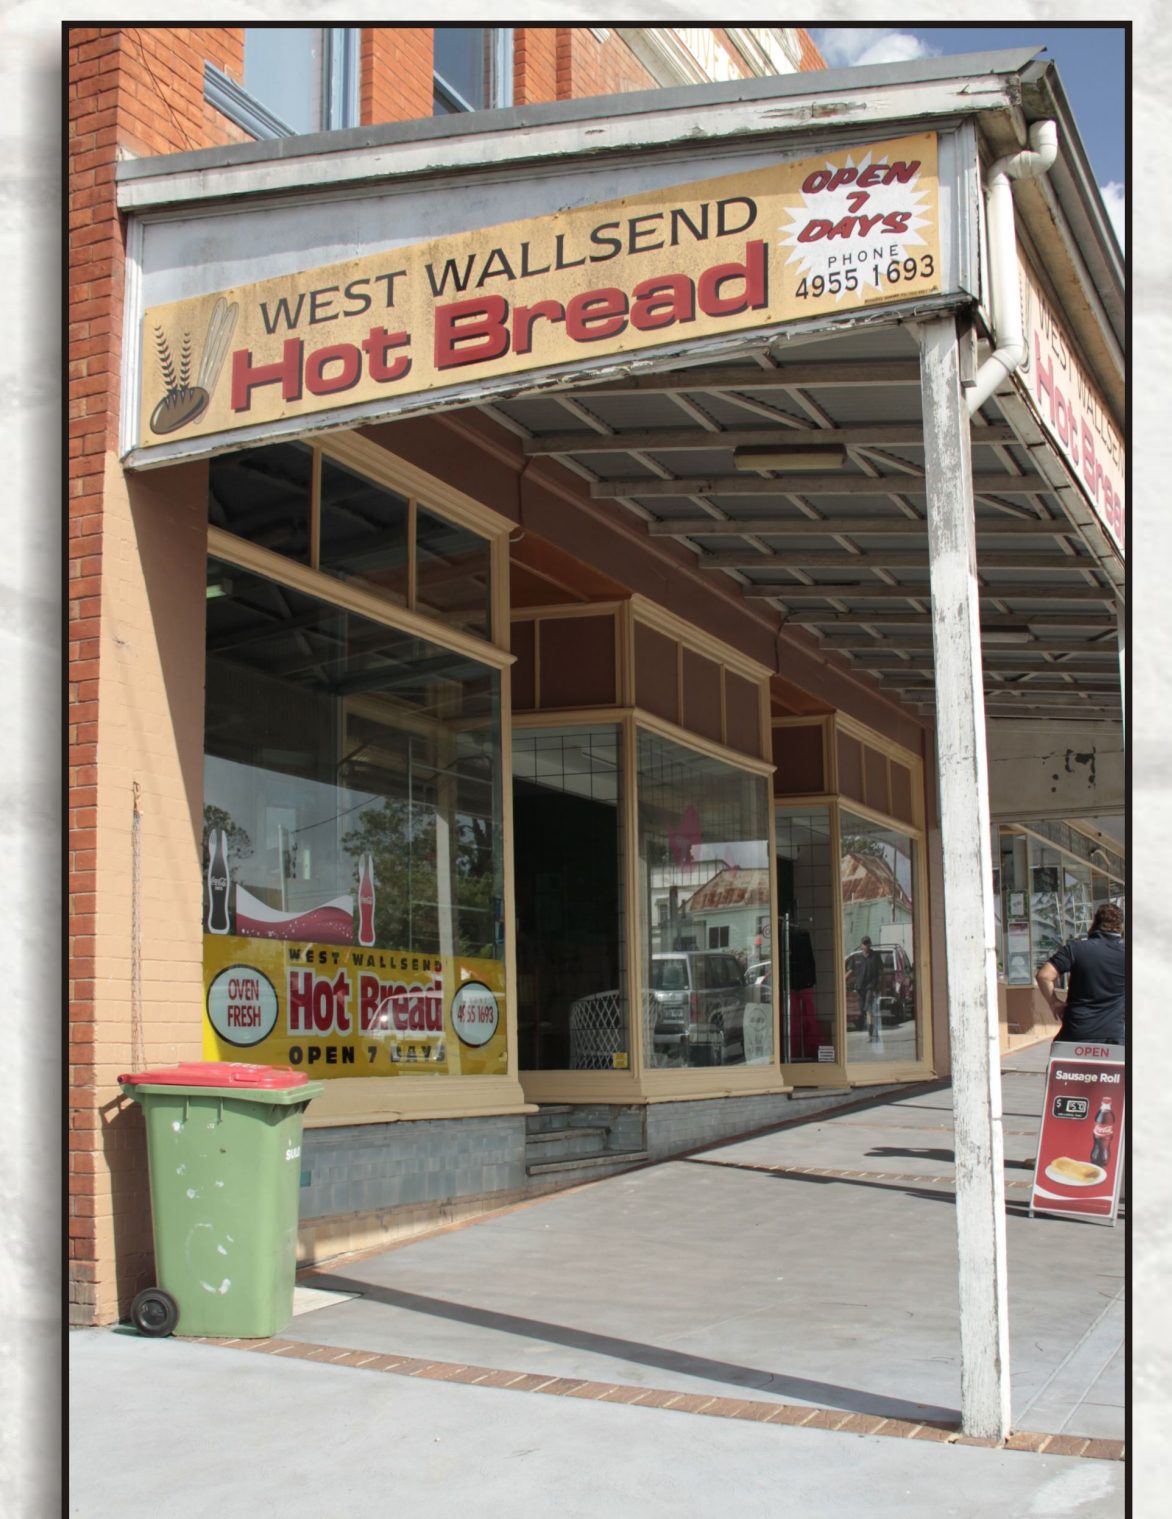
1906 built Co-op building on corner of Withers and Brown Street. The line of the 'Golden Mile' pavers are shown in the modern footpath.  
Image source: Umwelt (2013)

As part of the 2013 LMCC streetscape works, replacement pavers were sourced from Lincoln Brickworks and used, in the form of banding, to indicate the extent and locations of the original pavers. In addition, lines were etched along the inside edge of the new kerb to show the original width of the Golden Mile footpath and the likely location of the original kerbing (refer to **Plate 4.1**). Examples of the original brick pavers have been used in the brick banding between the newsagents and the IGA supermarket. Original brick pavers have also been installed on the eastern corner of Withers and Brown Streets.
