| INVENTORY of SITES & ITEMS |

| INVENT | ORY SUMMARY - LIST OF SITES & ITEMS | SI | AHA | PTON | - | SH |

SEAHAM No.1 COLLIERY SITE (Demolished), SEAHAMPTON ITEM No. NAME/IDENTITY: SH - 04

NAME/IDENTITY: SEAHAMPTON VILLAGE ITEM No. SH - 05

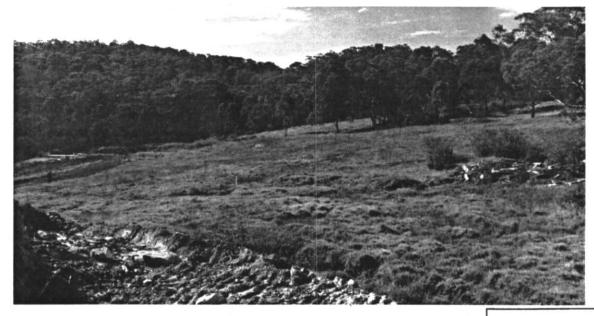
SH - 04 ITEM No.

Seaham No.1 Colliery site, (from PHOTOGRAPH &/OR SKETCH PLAN (and caption): the south). The pithead was in the left background, boiler houses etc. in the centre, & workshops on the right. A small pile of red bricks under a clump of trees (right background) is all that is left of a colliery house. A number of drains, stone lined or cut in rock, run along contours or down the hill. Some (heavily overgrown with thick grass) can just be made out in this photo. Bulldozer tracks (bottom left) show where all traces of coal boxes, railway (Doring Neg.300.22) sidings, etc. were destroyed in early 1991.

| NAME/IDENTITY SEAHAM No.1 COLLIERY SITE (Demolished), SEAHAMPTON SH - 04 | | | | | | | | |
|---|--|--|--|--|--|--|--|--|
| Physical Characteristics Archaeological Site Condition: All mine buildings were demolished several years ago. The site is now open ground, or covered by rubble and recent earthworks. Physical Archaeological Remains: The waggon loading and shunting area is clearly (above or below ground) visible as levelled land linked to the railway going to West Wallsend Colliery and on to Cockle Creek. Engine ponds remain. Position of some buildings might be found in level sites and/or buried brick footings. Possibly shafts remain below ground. Level areas and garden walls indicate the former site of management houses. Other physical details: | | | | | | | | |
| CONSERVATION ACTIVITY: None. All mine buildings have been demolished. Much of the site was further bulldozed 1991/92 for works incidental to the nearby Freeway construction. | | | | | | | | |

| NAME/IDENTITY SEAHAM No.1 COLLIERY SITE (Demolished), SEAHAMPTON SH - 04 | | | | | | | | |
|---|--|--|--|--|--|--|--|--|
| STATEMENT OF SIGNIFICANCE: The Site of Seahampton No.1 Colliery is significant as the site of the first mine of a major coal company, and the reason for the existence of Seahampton village. The significance of the site has been diminished by the recent near-total demolition. If this area is re-developed, the colliery ponds would make a good location | | | | | | | | |

for a pleasant small park, with some interpretation of the site's history.

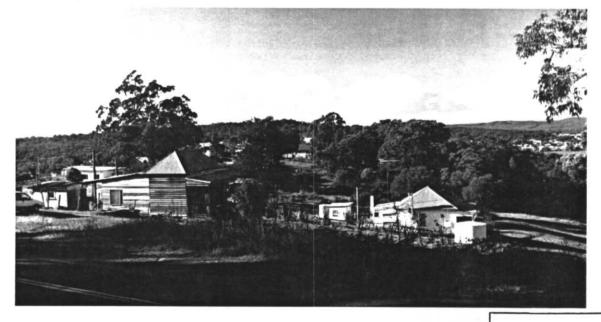
ITEM No. SH - 05

PHOTOGRAPH &/OR SKETCH PLAN (and caption): Two early miner's cottages in Seahampton, taken from the north end of the village, looking south. George Booth Drive is in the foreground. The white cottage (right) is further from a street than any other cottage in the village. It faces west, & appears to be occupying Lot 3 on 2nd St, a subdivided road which was never made. The tiny unpainted cottage faces 2nd St also. The valley (right) leads down to the site of the former Seaham No.1 Colliery. The township of West Wallsend can (Doring Neg.305-00) be seen beyond (in the distance, right).

Seahampton was formerly a mining village, & is now a small dormitory village with many new homes. It is sited on a ridge above the former Seaham No.1 Colliery, & has extensive views to S-E & S-W. Houses are aligned along both sides of George Booth Dr. (along the ridge), & along a few minor streets running off the east side of the ridge, facing away from the colliery site. Only a small number of scattered houses were built in the mining-era, & a large proportion of these

New houses in the village are usually built on vacant allotments, DESCRIPTION: with little pressure to demolish the older houses. Subdivision plans allowed for more streets (seven) & for more houses than were actually built. Fourth, Fifth & Seventh Streets exist, & Third Street is now George Booth Drive, but First, Second & Sixth Streets were not made. There must have been a footpath leading from the village to the working colliery. There are now fences between the roadway and the colliery site, with no clearly visible pathway.

RECOMMENDATION: Retain the name & layout of Seahampton village & its streets, & ensure that any extensions follow the original pattern. Provide a clearly identified public footpath from the village to the former No.1 Colliery site.
