FIGURE B1  
JUNE 2007  
QUESTIONNAIRE RESULTS

FIGURE B2a  
**PEAK HEIGHT PROFILES**  
**JUNE 2007**  
**NORTH CREEK MAIN**

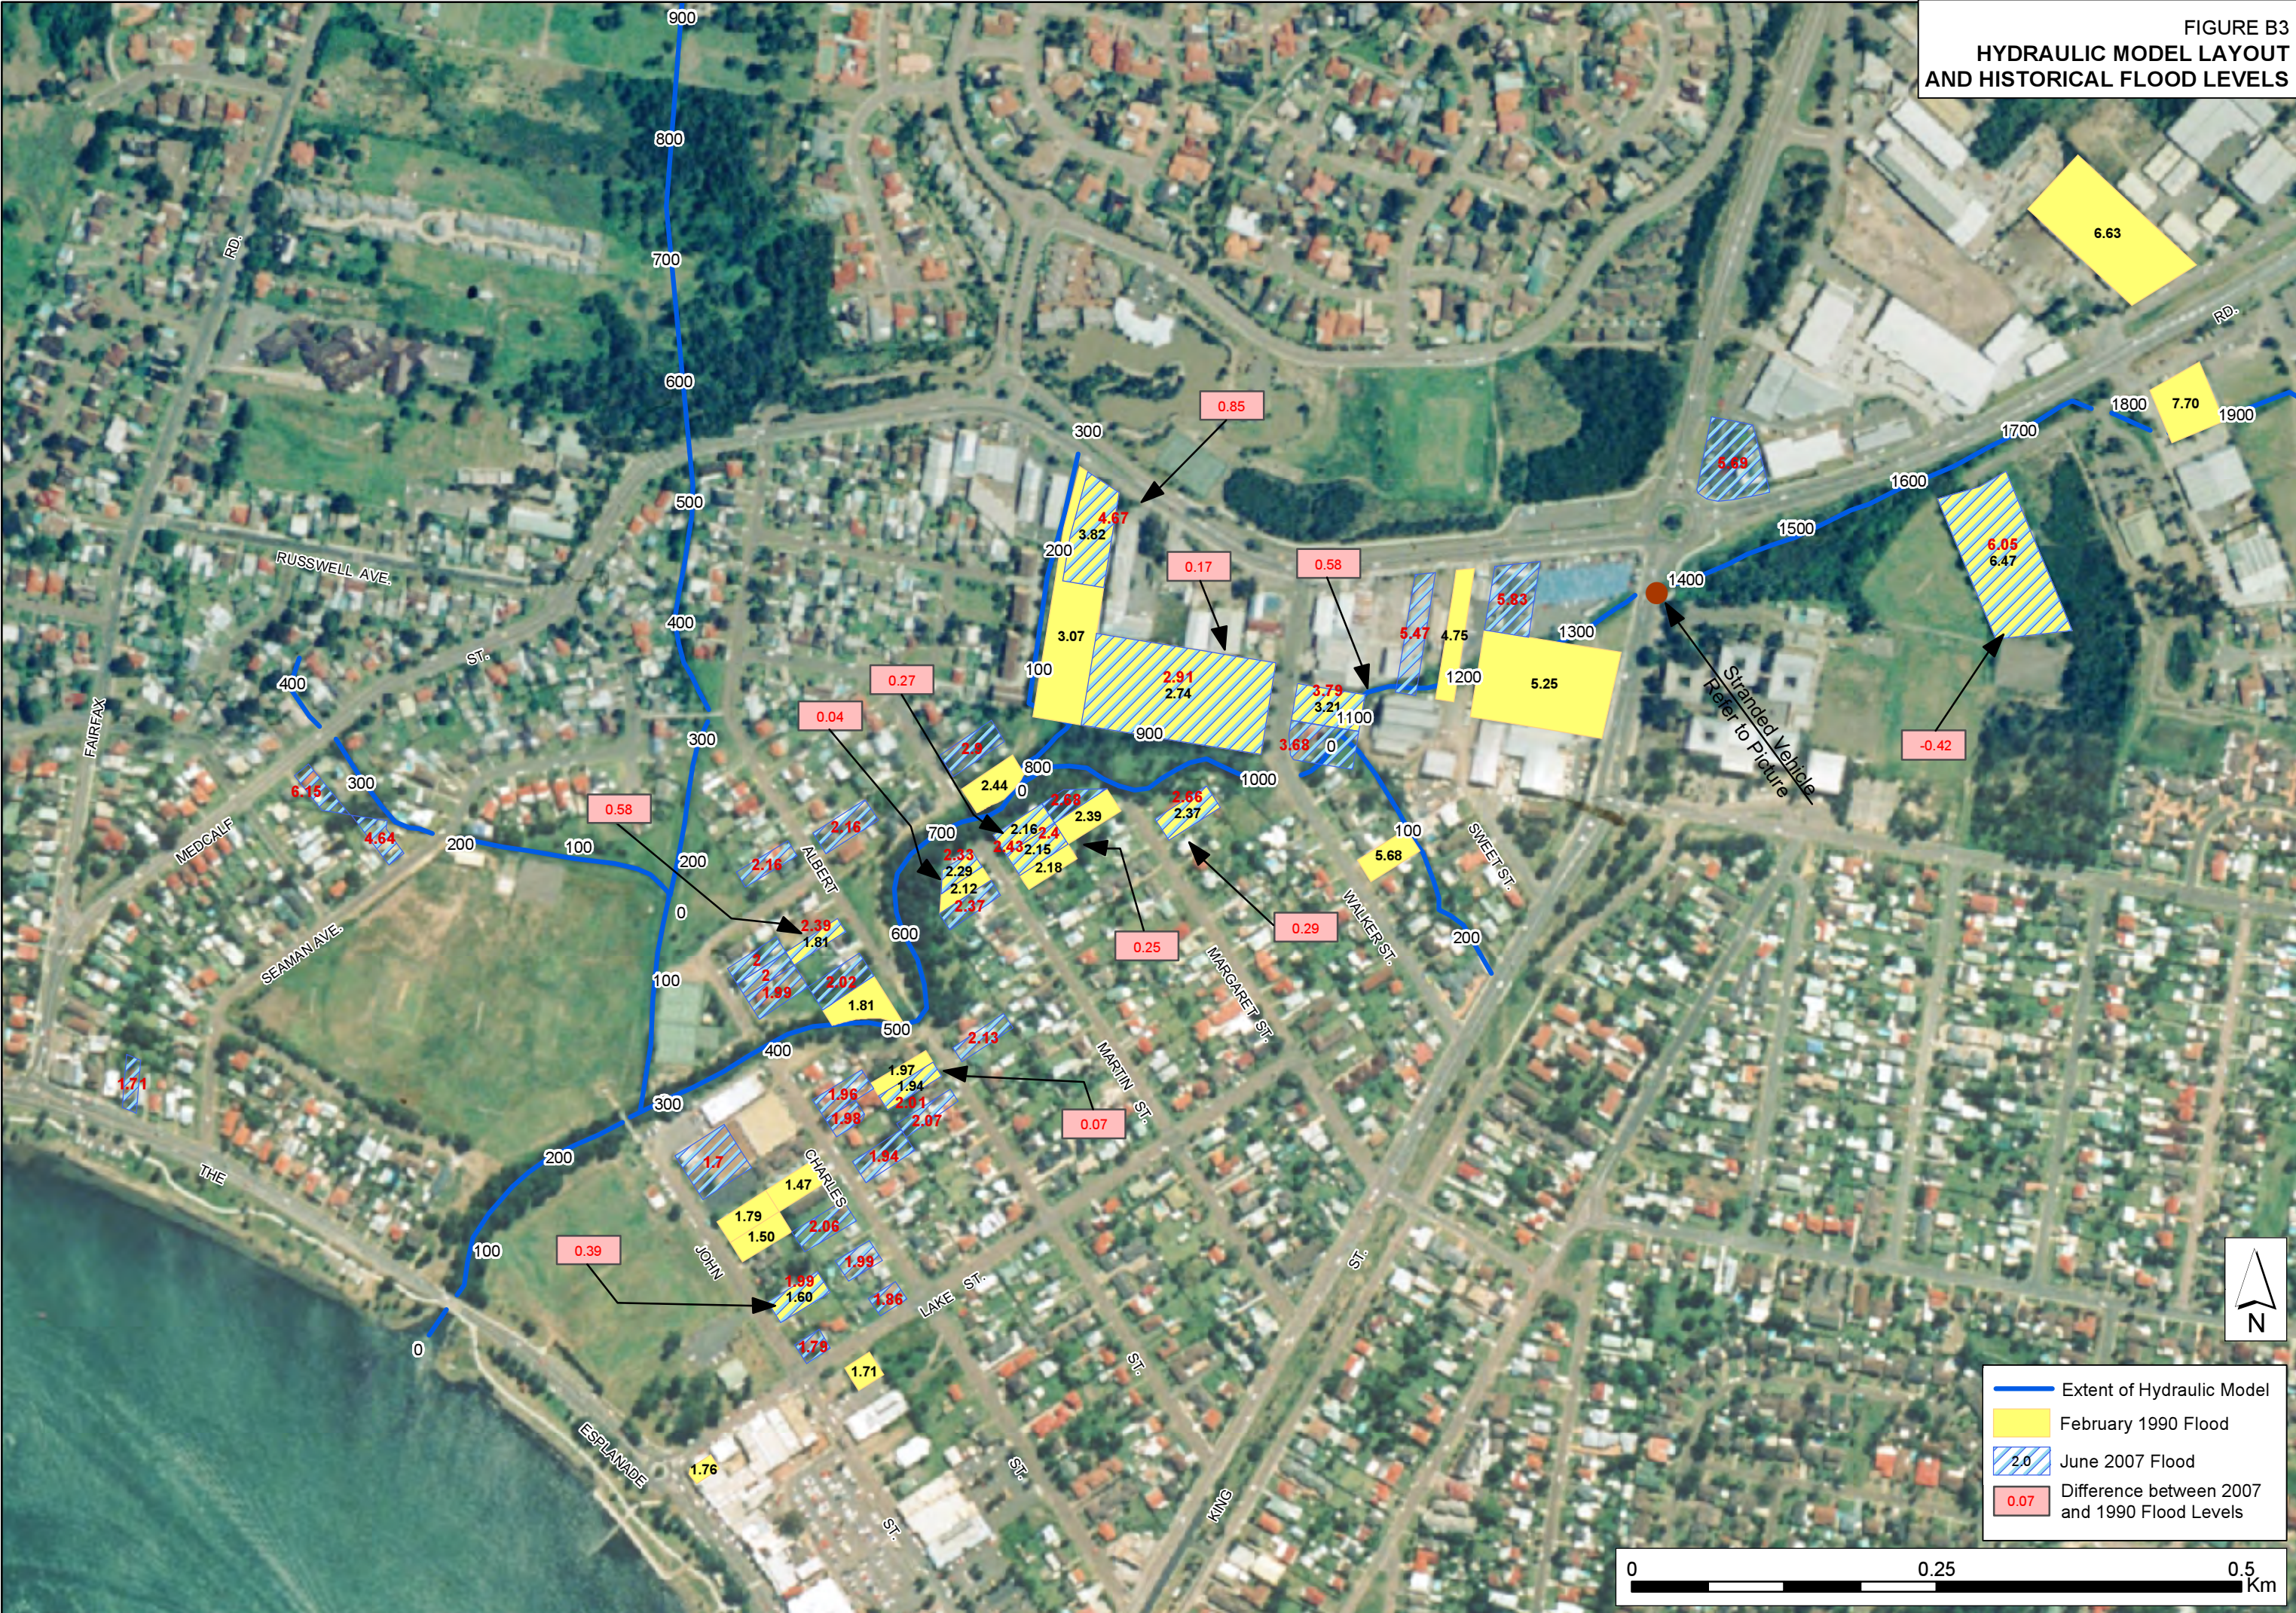
FIGURE B3  
HYDRAULIC MODEL LAYOUT  
AND HISTORICAL FLOOD LEVELS

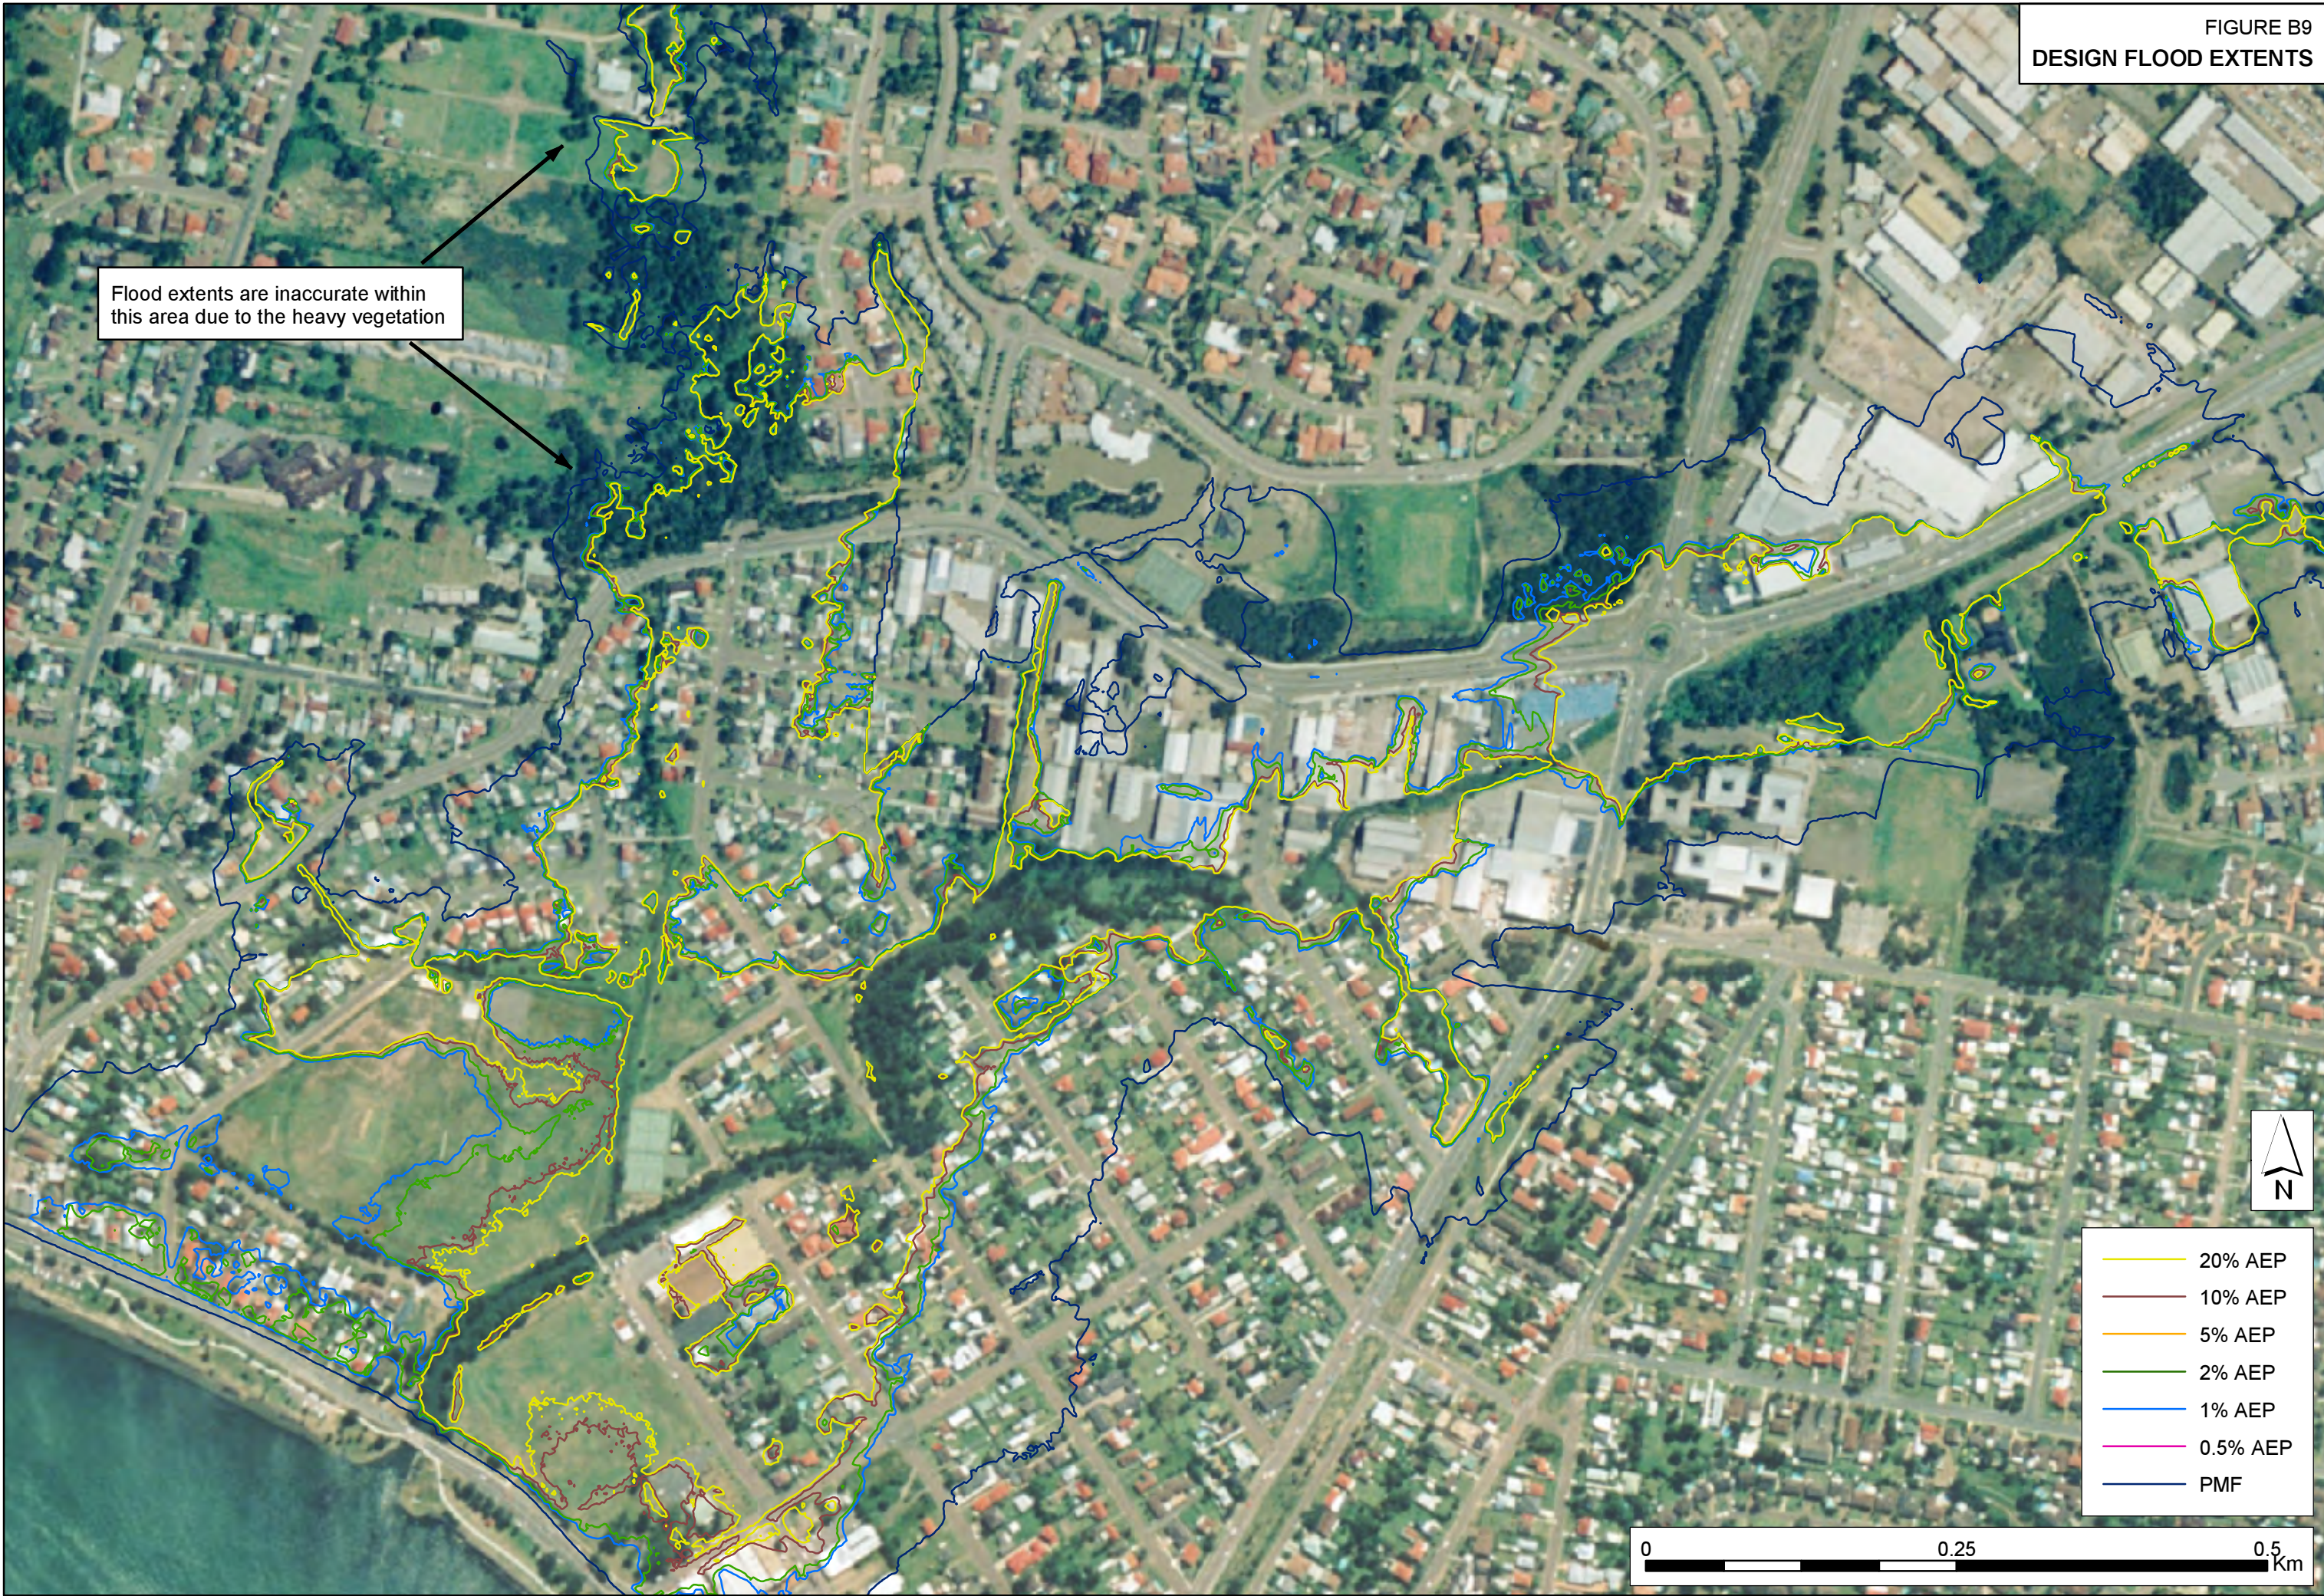
FIGURE B9  
DESIGN FLOOD EXTENTS

Flood extents are inaccurate within  
this area due to the heavy vegetation

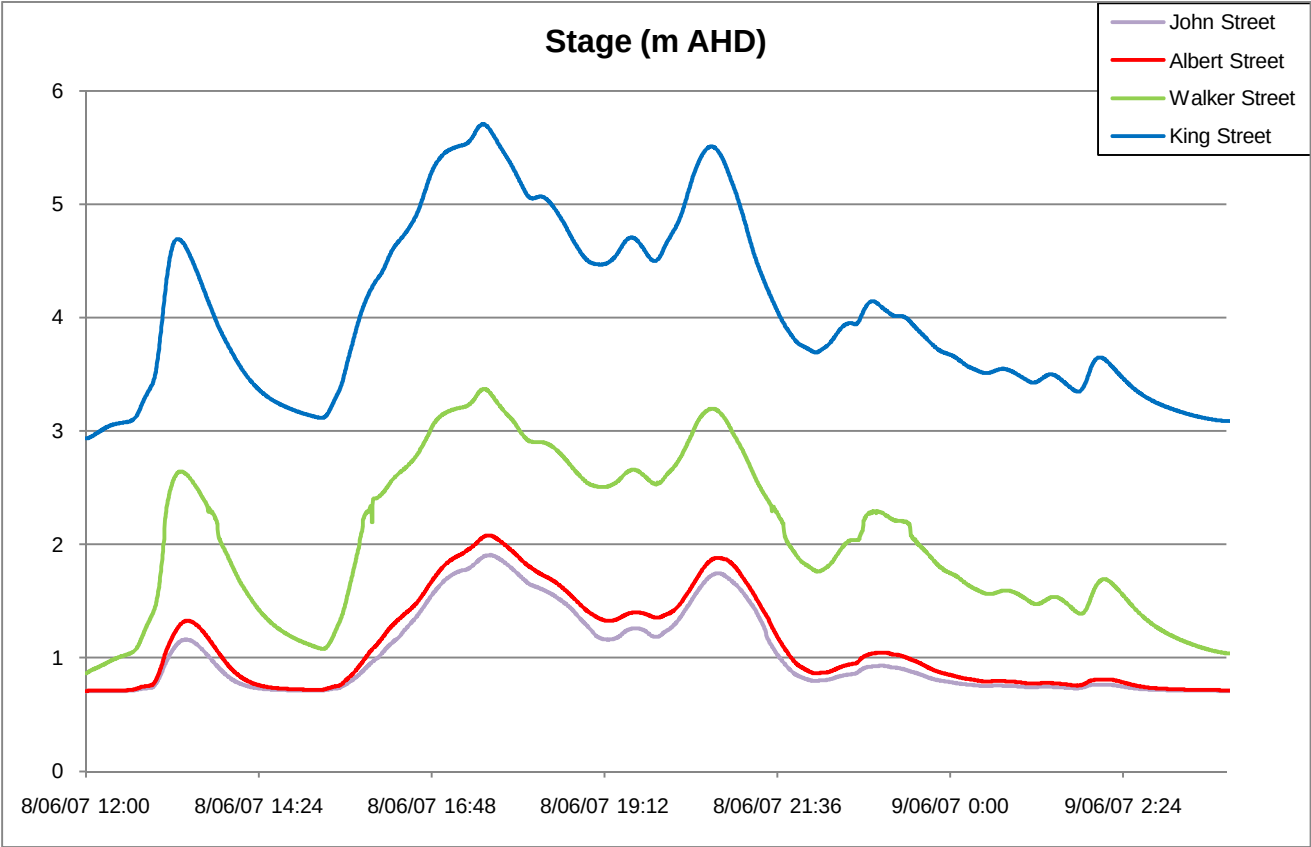
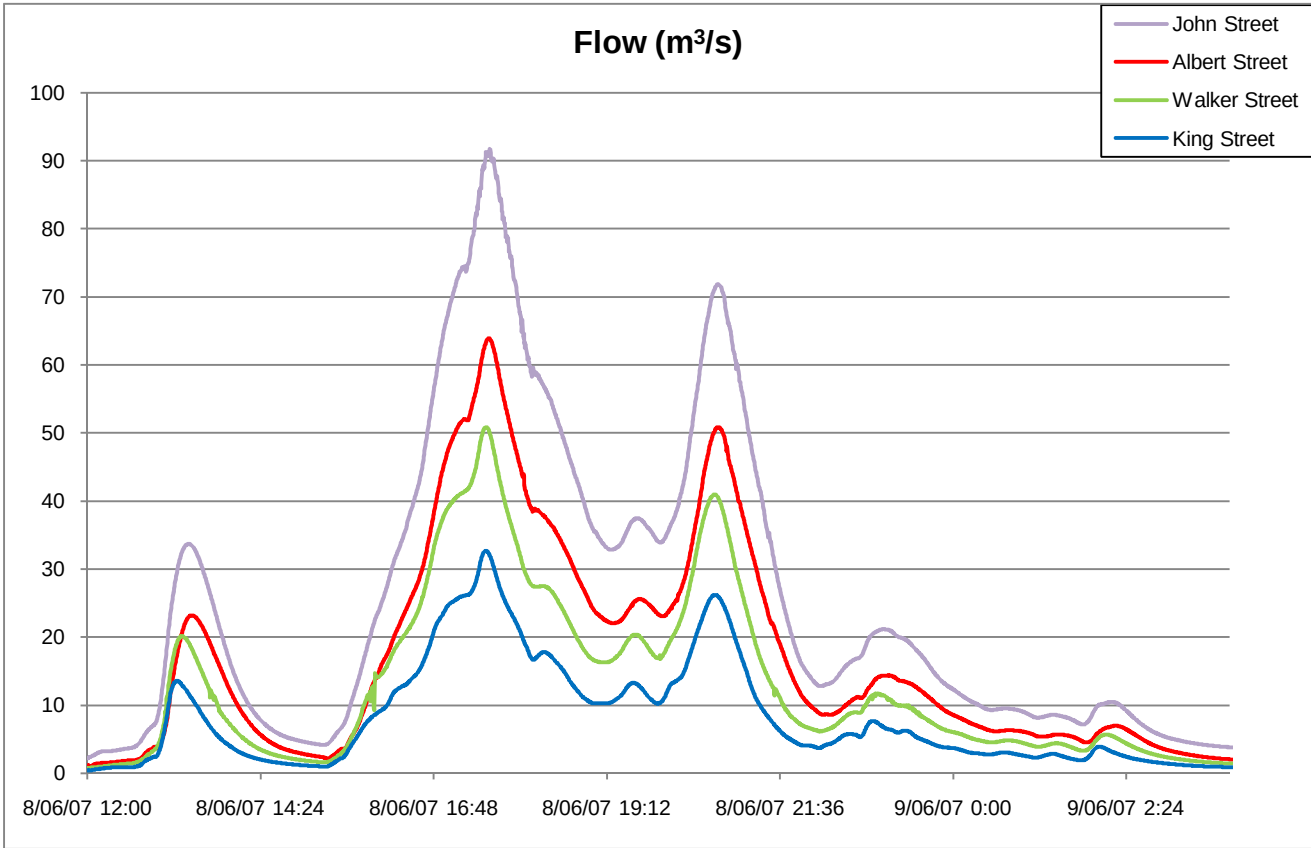
FIGURE B10E  
COMPARISON OF HYDROGRAPHS  
2007 EVENT
